Case Study

St Congar's Church

Badgworth

Conservation of the bell tower including structural support and restoration of lime render.

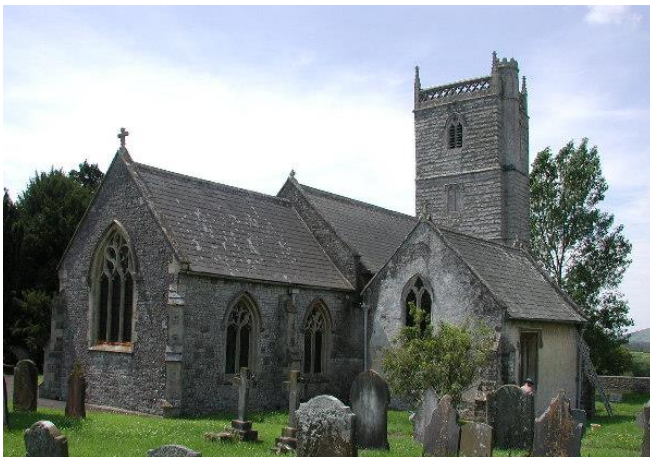
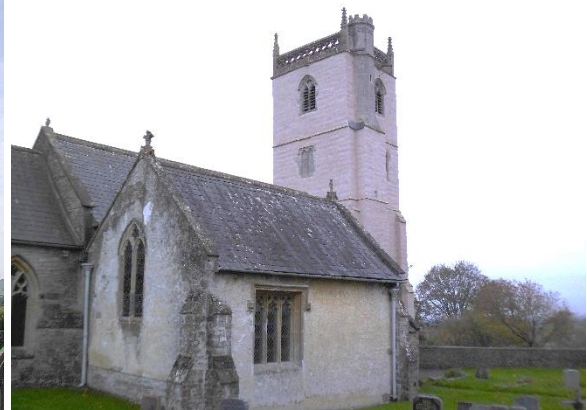
St Congar's Church before and after the conservation work

Damp, bell vibrations and historic cement repairs had loosened masonry and created wide gaps in the stonework. The cement pointing was removed and the stonework cleaned.

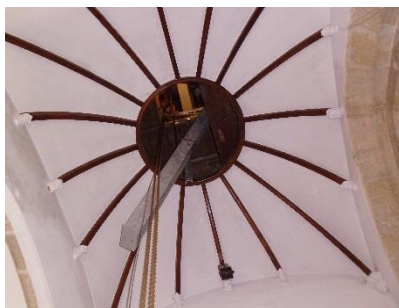
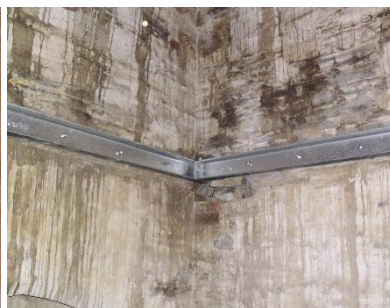
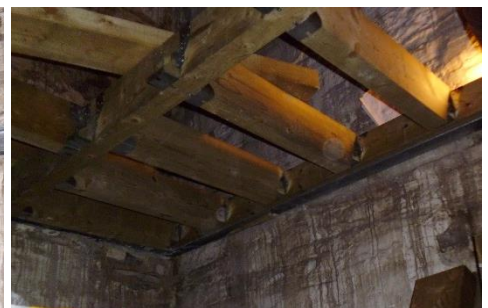
Steel beam being raised through the bell tower. The new steel and timber construction will hold the bell tower together.

Stainless steel beams and anchors were installed in the bell tower to support the church bells and hold the tower together. The bells themselves were removed and stored safely for a programme of further restoration.

Additional supports were installed around the window in the towers' deadening chamber, and floor joists in the belfry were replaced with new air dried oak.

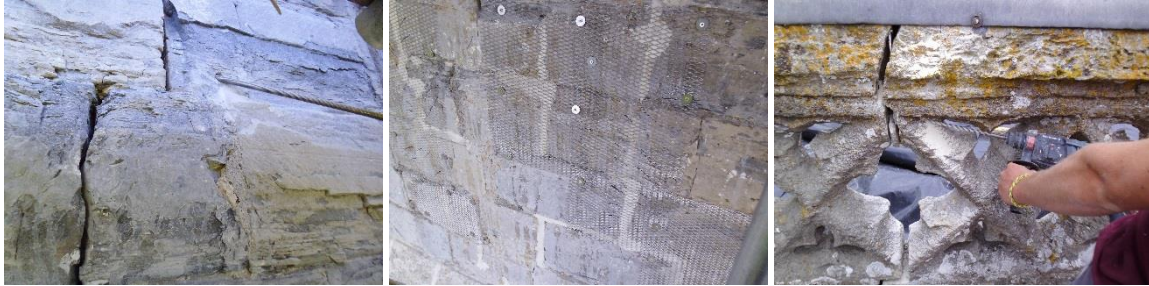
Repairs in progress showing removal of poor historic repairs and securing repointed stonework with steel mesh.

A gentle pressure steam system which is sensitive to historic stonework and chemical free was used to clean the stonework. Ellis and Co masons repaired a series of large cracks in the masonry.

Structural Cintec anchors were installed to provide structural support around damaged lintels. Stainless steel lath supports were used to consolidate larger cracks in the masonry. The roof parapet stones were unstable due to poor cement repairs so were restored by Ellis and Co masons. Missing louvres in the belfry windows were replaced with new ones carved by Ellis and Co Stone masons to match original materials in shape colour, texture and size.

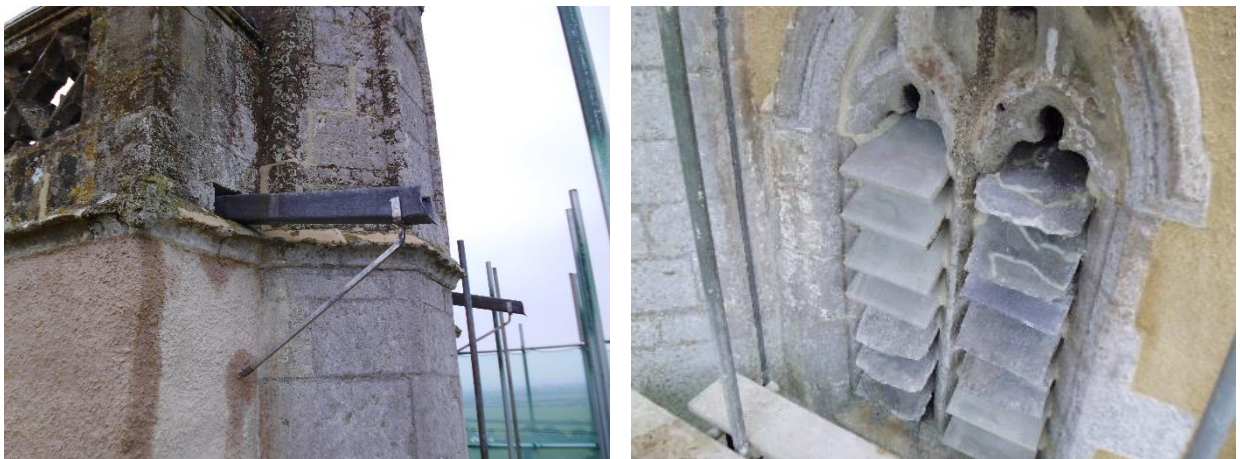
Specially commissioned lead shutes in place supported by steel fixings, and new belfry louvres blend with originals.

The 1930s roof was perished and loose flashings, intruding vegetation, and short lead shutes had caused water damage and beetle infestations in the beams bearing the roof. Our joiners extended the rafters with modern oak inserts. With this firm structure in place we re-leaded the roof and fitted new lead drainage gutters and shutes held in place by stainless steel supports to making the roof watertight.
