Case Study

Holy Trinity Church

Blackford

Internal works including replastering, redecoration, new services and improvements.

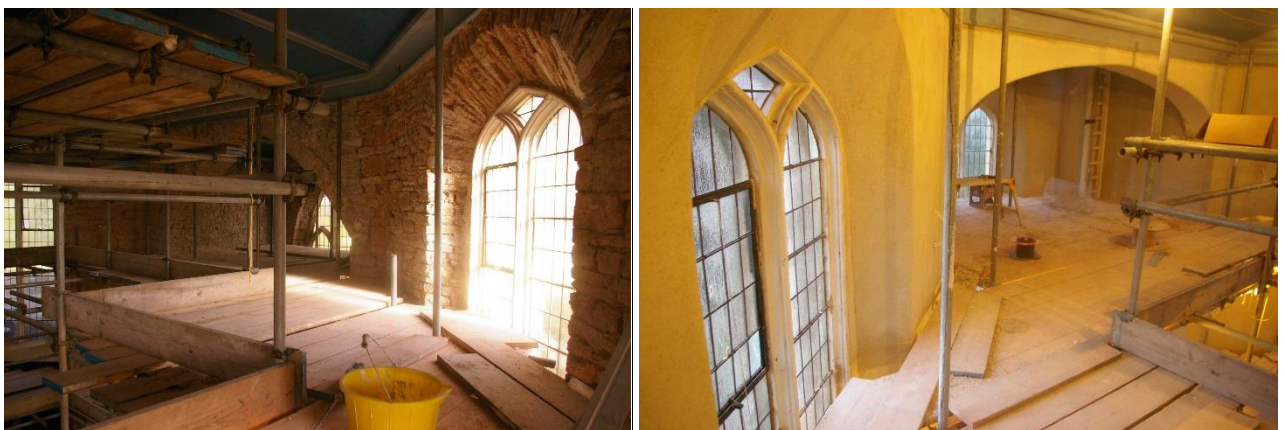
Internal masonry was repaired, lime plastered and painted in conservation paints

Internally both walls and ceilings were repaired by our masons, lime-plastered and painted in clay-based restoration paints. Mouldings around the windows were repaired, eroded window bars replaced with steel, and panels re-glazed with new quarry glass. A central octagonal pendant light, carved by our joiners and decoratively gilded now adorns this beautifully restored church.
