Case Study

Fonthill Abbey

Wiltshire

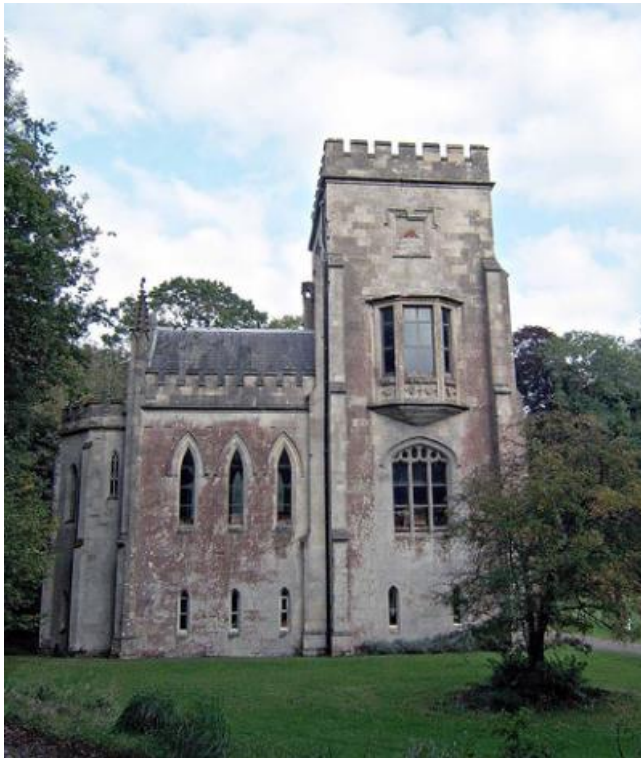
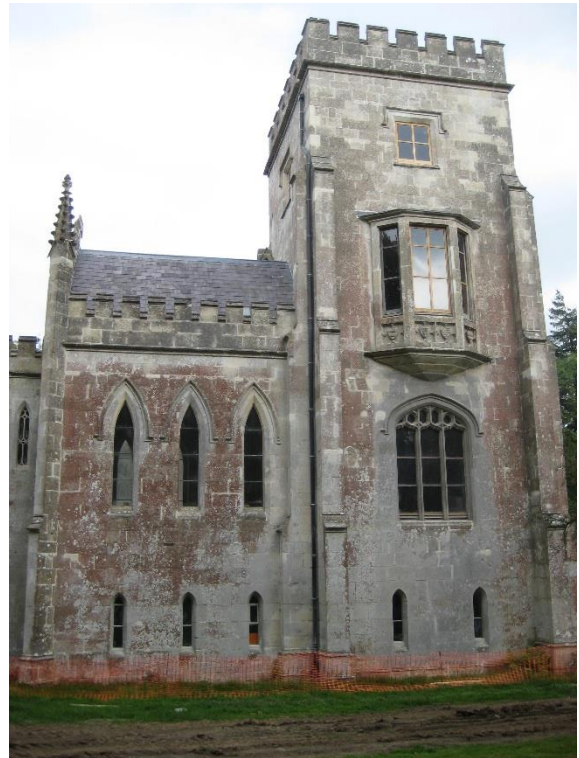
The tower of the north wing before and after works showing the new windows and stone repairs.

The windows throughout were stripped down and repaired, including the Oriel window shown above which required additional structural support once cement and ironwork were removed. A large section of bulging ashlar was removed and replaced with stonework designed to match and fit neatly alongside surrounding stonework.

Stonework was cleaned, biological material removed, and stonework repaired. Corroded iron cramps were cut out and where necessary new steel cramps were inserted. Surrounding masonry which had been damaged by the ironwork was repaired. New Chilmark stone was cut and pieced in to fit neatly and tightly alongside existing stonework. Smaller gaps and joints were cleaned and filled with mortar.
