Salisbury Guildhall

Re-Roofing

A programme of roof repairs and installations to this Grade II civic building.

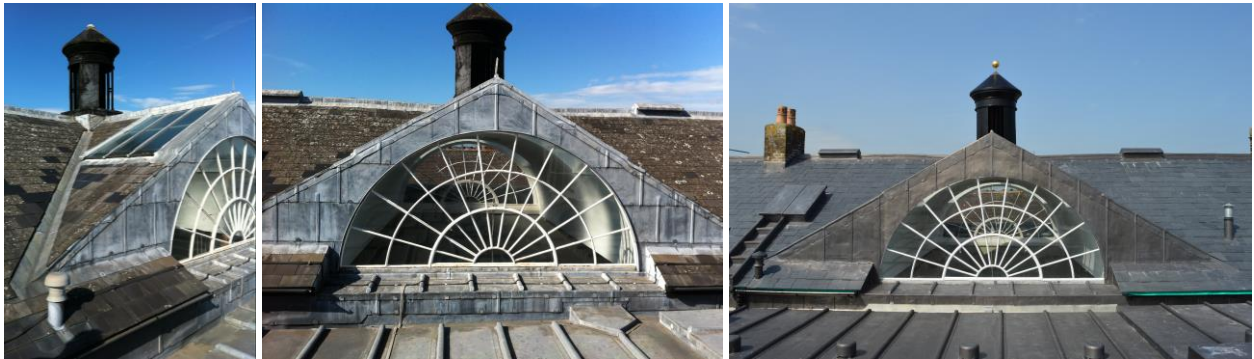
Before and after slating, leadwork and glazing repairs
