# Case Study

## Wells Cathedral

### Roof conservation and repair

An impressive 12<sup>th</sup> Cathedral in the heart of the City of Wells. The western half of the north nave aisle roof is laid with lead and had suffered from severe water ingress. Between March and Oct 2015 Ellis and Co repaired the roofs under the instruction of Nick Cox Architects.

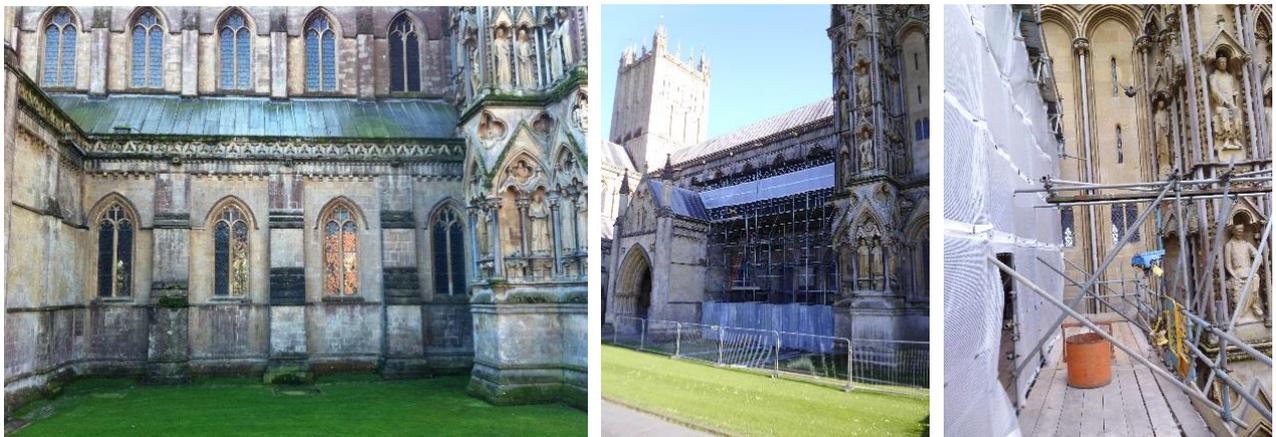
*Nave roof before and during works.*

We erected scaffolding internally and externally to create a temporary roof.

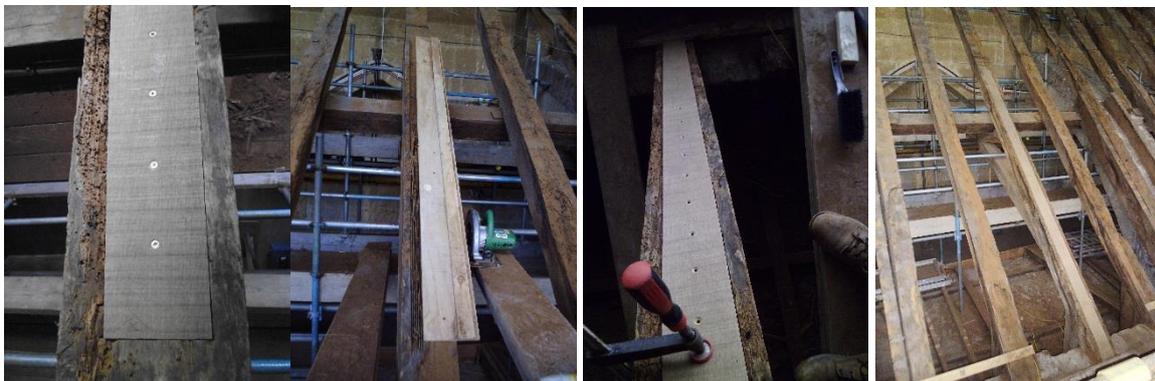
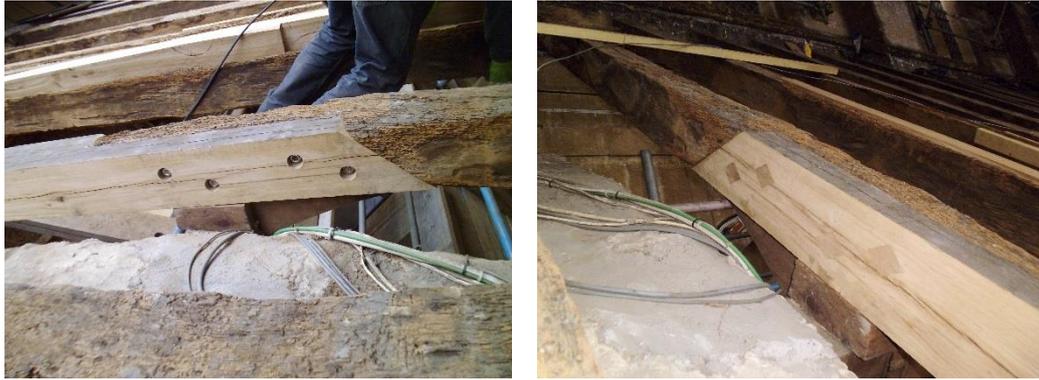
*Further timber repair details*

The roofing timbers repaired dated between the post-medieval period and mid-eighteenth century with some additional repairs identified as mid 1930s or earlier. Each timber was assessed and the repairs made to the substrate and roof structure aimed to conserve and support the original timbers wherever possible with fitted oak inserts, diamond oak pellets, and wedges. We also added firings to aid water drainage.

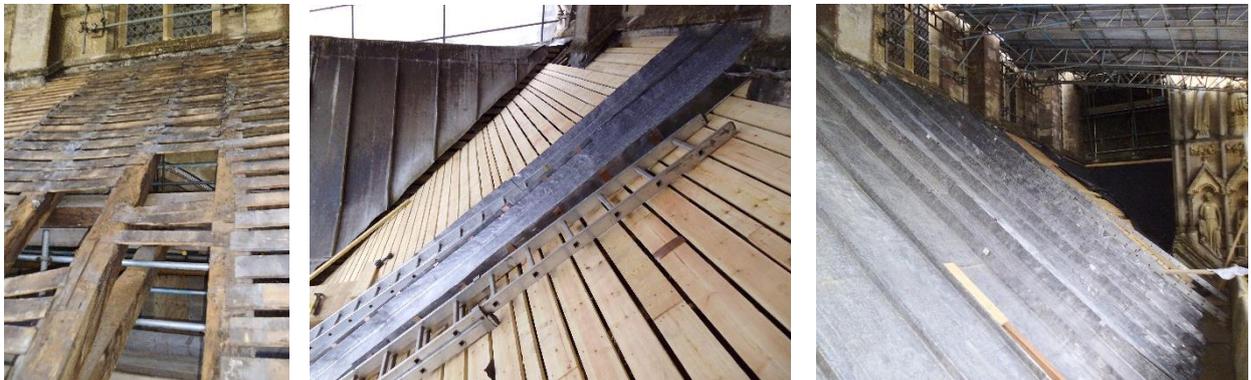
*Before, during and after the repairs.*

We stripped, recast and relaid the lead roof including bays, flashings, guttering, and details including a lead step detail and ornamental features. We unblocked the chutes from the main north nave roof to discharge water.

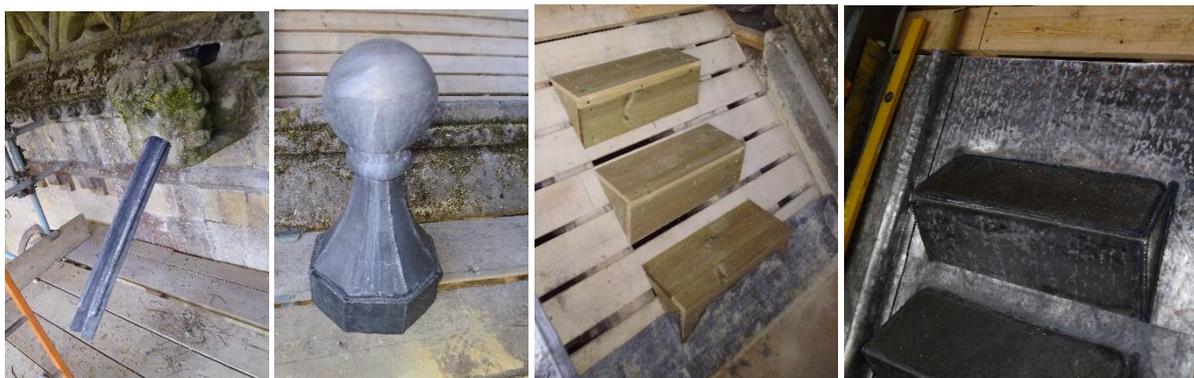
*Leadwork details*
