Case Study

Holy Trinity Church

Blackford

Internal works including replastering, redecoration, new services and improvements.

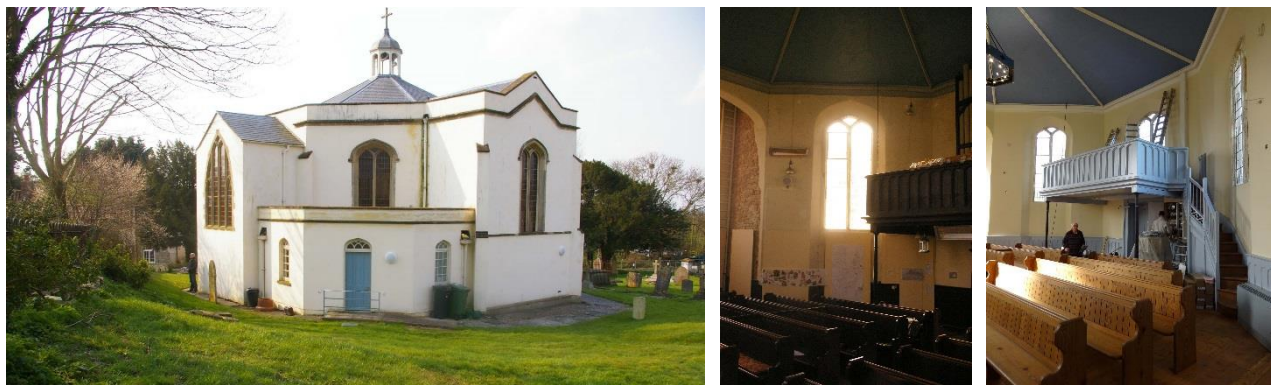
External render was repaired. Internal walls, ceiling, lighting and joinery before and after completion of the works.

External walls were gently cleaned, repaired, and repainted. Internal furniture including the lectern, alter rails, table, pews were taken to our warehouse for restoration using traditional joinery techniques. Pews were resized, rubbed back and finished with beeswax. The floor was lifted and repaired with matching timbers. Electrical, lighting and heating systems were replaced. A projector screen with winch was fitted. The kitchen and WCs were refurbished with bespoke furniture.

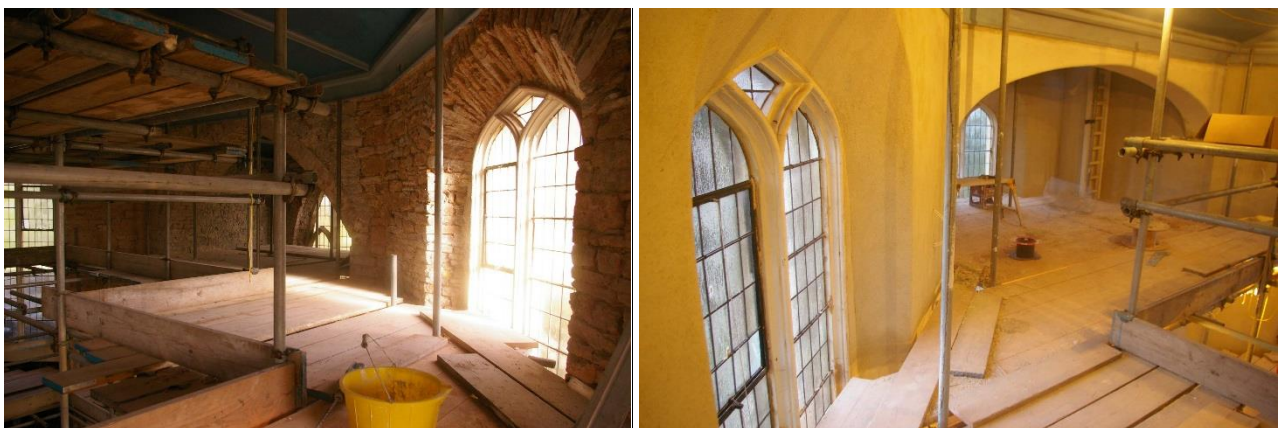
Internal masonry was repaired, lime plastered and painted in conservation paints

Internally both walls and ceilings were repaired by our masons, lime-plastered and painted in clay-based restoration paints. Mouldings around the windows were repaired, eroded window bars replaced with steel, and panels re-glazed with new quarry glass. A central octagonal pendant light, carved by our joiners and decoratively gilded now adorns this beautifully restored church.
