Case Study

Salisbury Guildhall

A programme of internal redecoration and later a programme of roof repairs and M&E installations to this Grade II civic building.

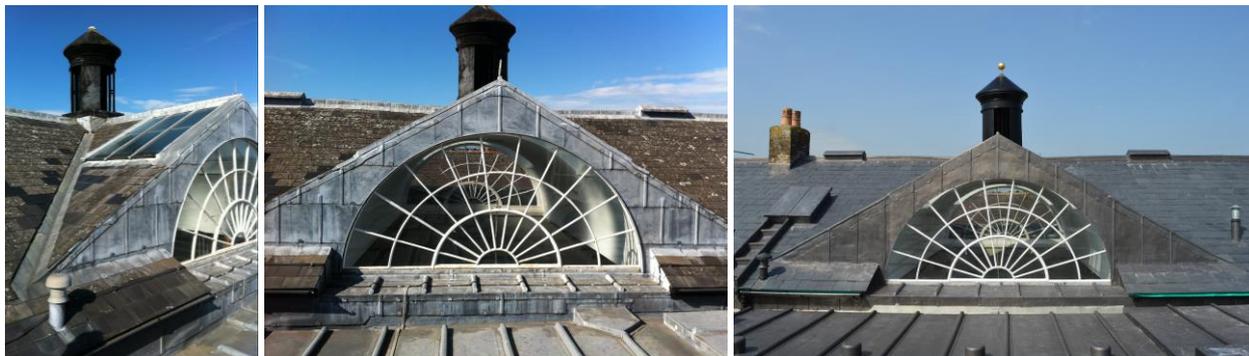
Before and after slating, leadwork and glazing repairs

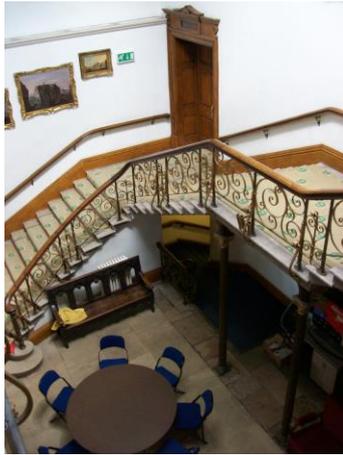
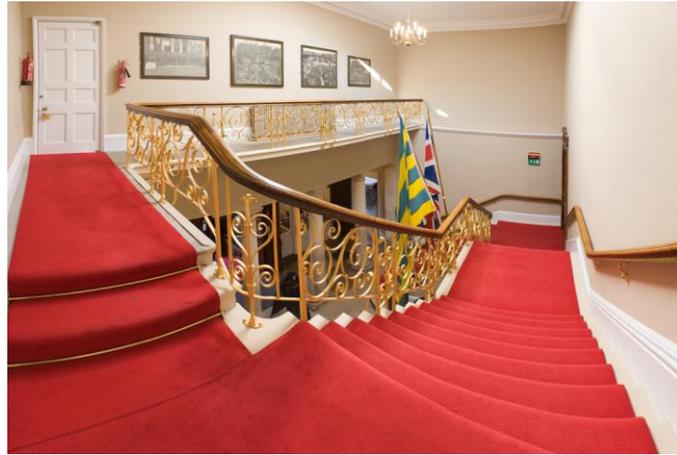
The entrance hall before (left) and after (right) conservation of the stair rails, redecoration and re-flooring and carpeting. Ironmongery was repaired throughout and a new steel staircase installed in the reordering of offices

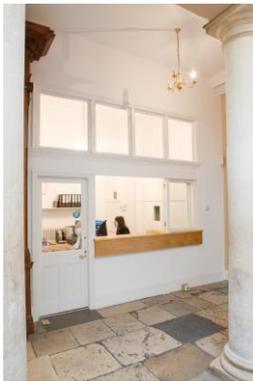
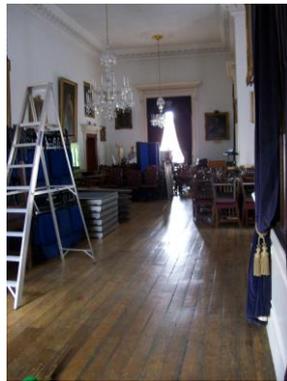
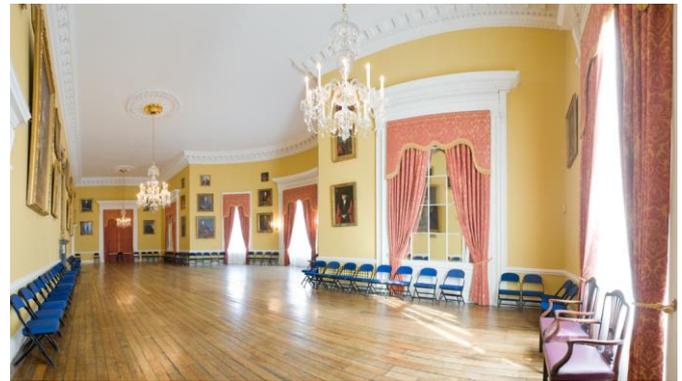
New office space was created and the building was redecorated throughout including the Banqueting room before and after shown above.

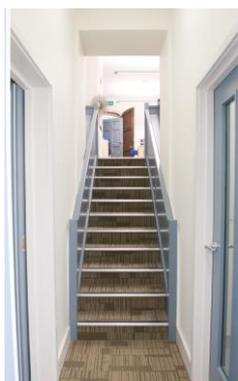
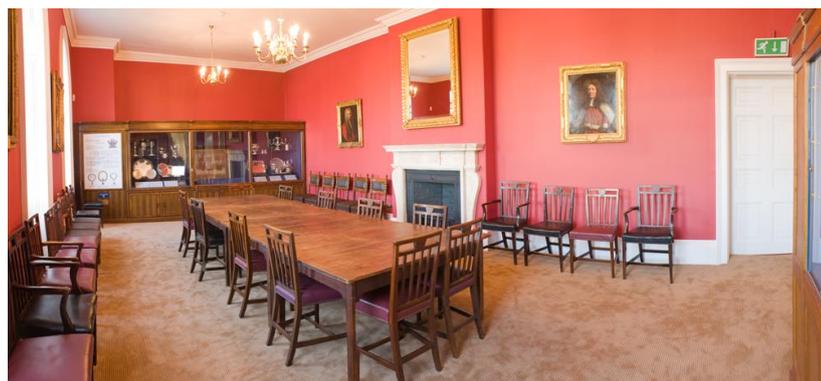
The new office layout included installation of a steel framed staircase (left). Flooring was installed, walls repaired replastered and repainted throughout. The venue now provides a base for the council staff and council meetings and a fabulous venue for weddings and functions.
