# Case Study

## St Marys Church

### Westonzoyland

**A programme of major repairs and reordering of this 15<sup>th</sup> C church has been completed including replacement of the nave roof coverings, external masonry repairs, repair of many glazed clerestory windows, provision of a servery, electrical services, internal repairs and redecoration.**

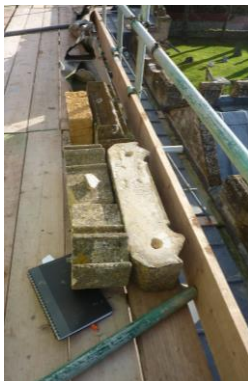
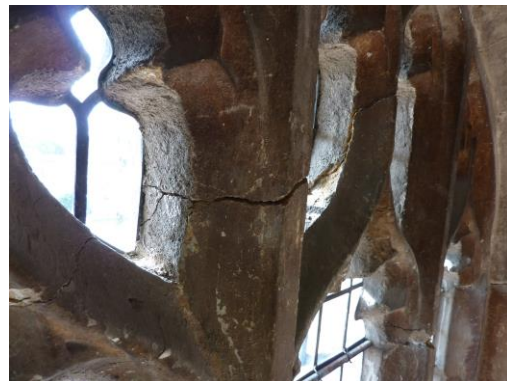
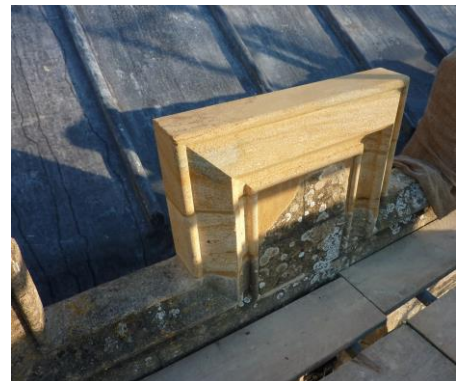
Defective masonry was repaired and where necessary replaced. Extensive mortar repairs have been made to the masonry, particularly around the clerestory windows where defective earlier repairs and ferrements were causing damage to surrounding masonry. Architectural features including crenellations, watershutes and gargoyles have been structurally pinned and repaired. Stonework has been cleaned of vegetation and sooty deposits with gentle brushing, a low pressure system and the application of poultices. A cleaning trial was undertaken before rolling out a wider programme of poultice work.

Masonry repairs in progress left and middle, and right after repair.

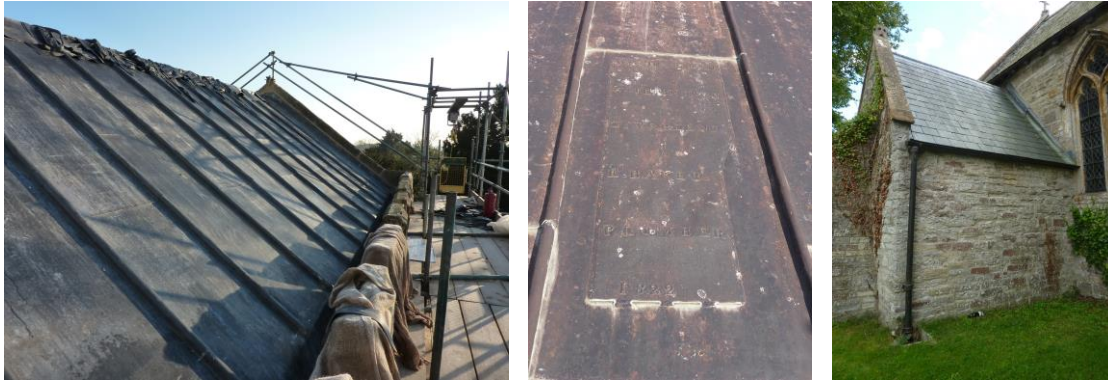
Roof repairs

We undertook timber repairs to the roof structure and treated it against beetle infestations. We then re-covered the lead and slate pitched roofs. We recorded embossed leadwork dating from the 19<sup>th</sup> C.

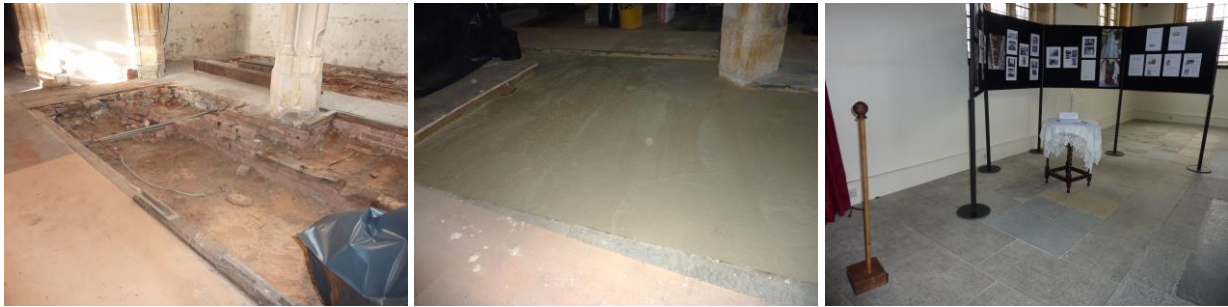
Before, during and after floor repairs.

The floor was excavated, underfloor services such as under pew heating was installed. The floor was then limecreted and laid with new Portland stone. The internal walls were in a poor state and defective cement and lime render was removed and replaced entirely below 1m and selectively up to ceiling level. Asbestos was found and a specialist subcontractor commissioned to remove it. The new clean lime rendered and clay painted finish has brightened the church and highlights the beautifully carved timber detail in the nave roof.

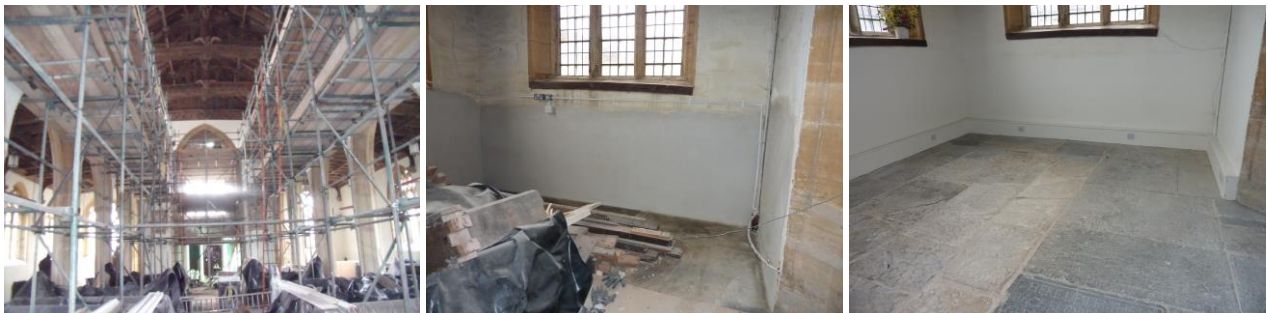
Scaffolding up to the clerestory windows enabling render and masonry repairs. Middle (during) and right (after) render repair and new flooring.

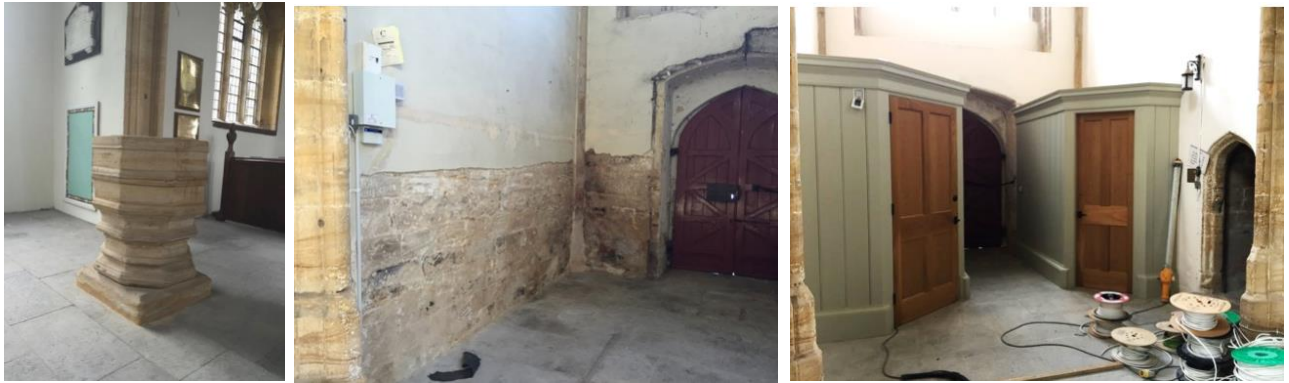
(left) The font re-situated on a plinth and new portland flooring, (middle) after the removal of the church organ, (right) the installation of toilets.

Features including a 14<sup>th</sup> Century font were repaired and relocated from the south door to the front of the church. Pews were removed and others resituated to create a flexible seating space.

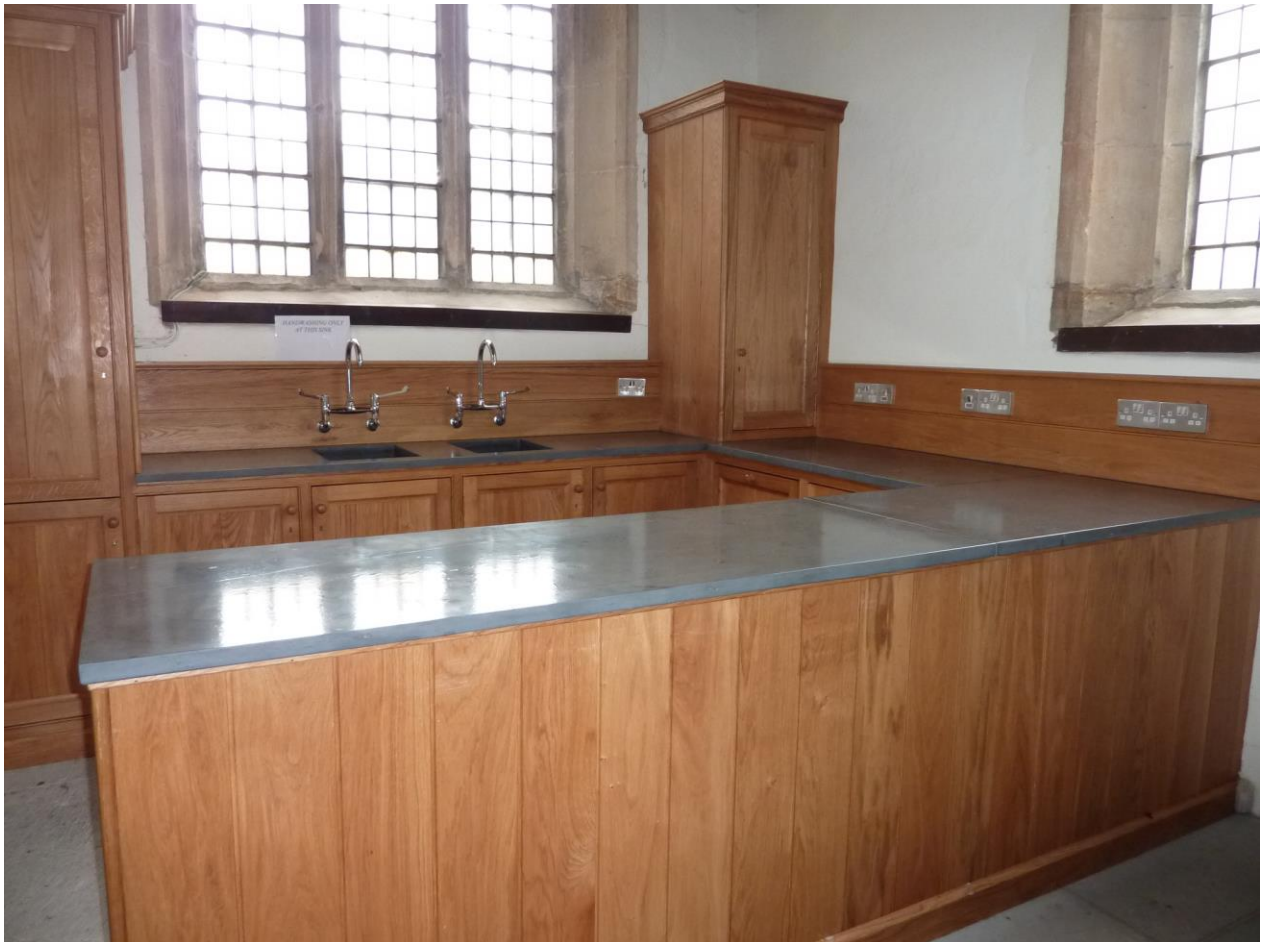
The new kitchen servery.

New toilets with disabled access, heating and handdriers were constructed and installed (shown above). A new bespoke servery with oil-finished Oak joinery, ironwork and blue lias worktops was made in the Ellis and Co joinery workshops. Fire alarm systems, electrical and plumbing services and a new boiler and white goods were installed.
