Case Study

Halsway Manor, National Centre for Folk Arts, Crowcombe

HLF funded programme of repairs and redecoration.

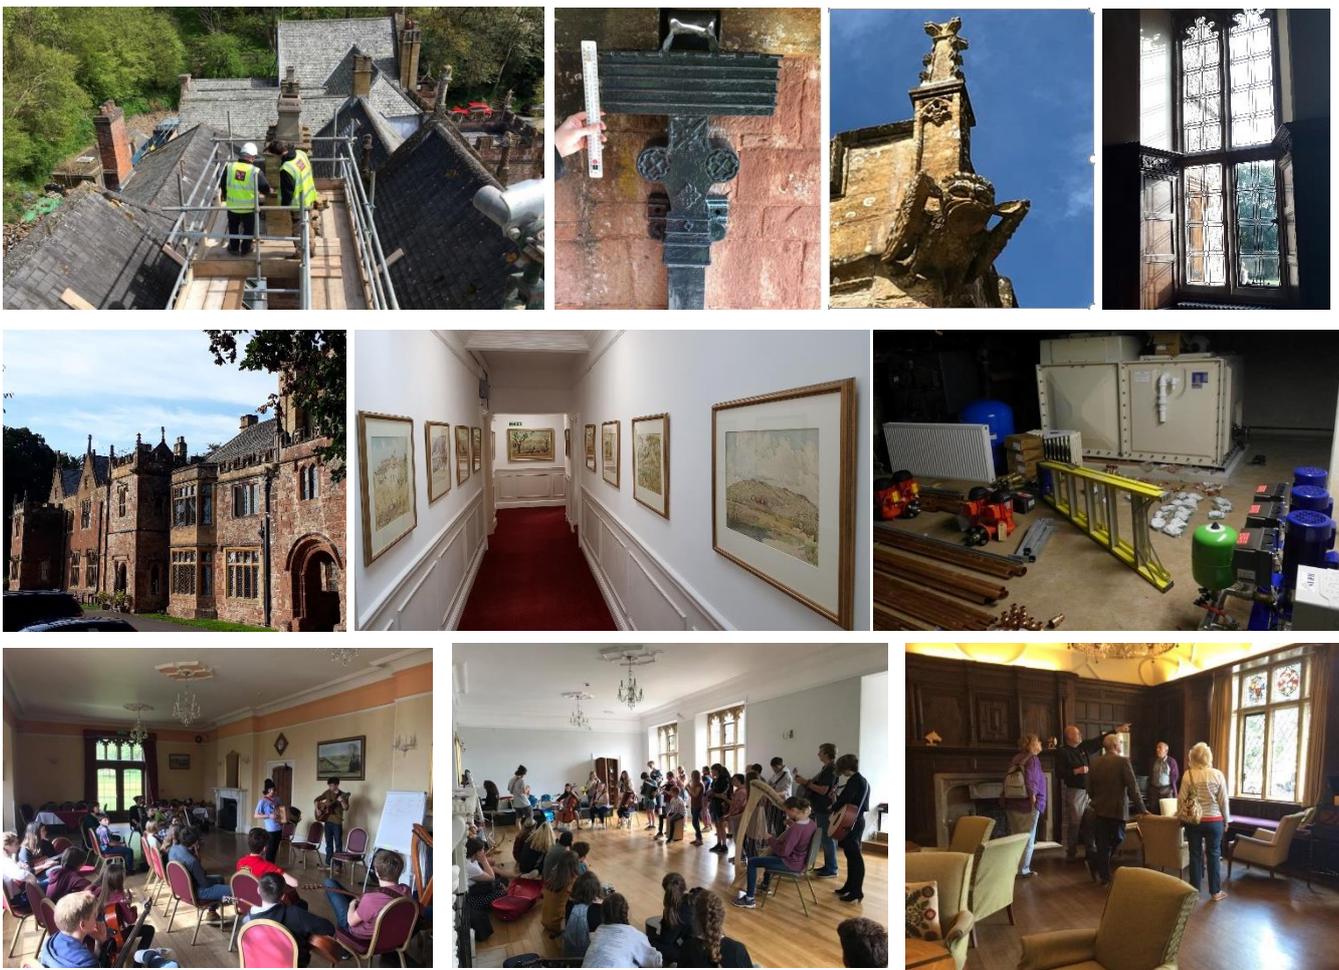
*Top Row: Chimney repair inspection, cast iron rainwater goods, detail of carved masonry.
Mid row: Halsway façade after, window repaired, boiler room prepared for installation.
Bottom row: Ballroom before decoration, after decoration, and the bar after refurbishment.*

Externally we re-slatted the roof and repaired the chimneys and cast iron rainwater goods. Ladder brackets were installed for future access. Masonry repairs were undertaken including the removal of cement fills, repair of stone surrounds and stitching repairs. Doors and windows were repaired and redecorated. Glazing repairs were undertaken on broken panes.
