Case Study

St Peter's Church Langley Burrell

Craftsmen in the
Conservation of
Historic Buildings

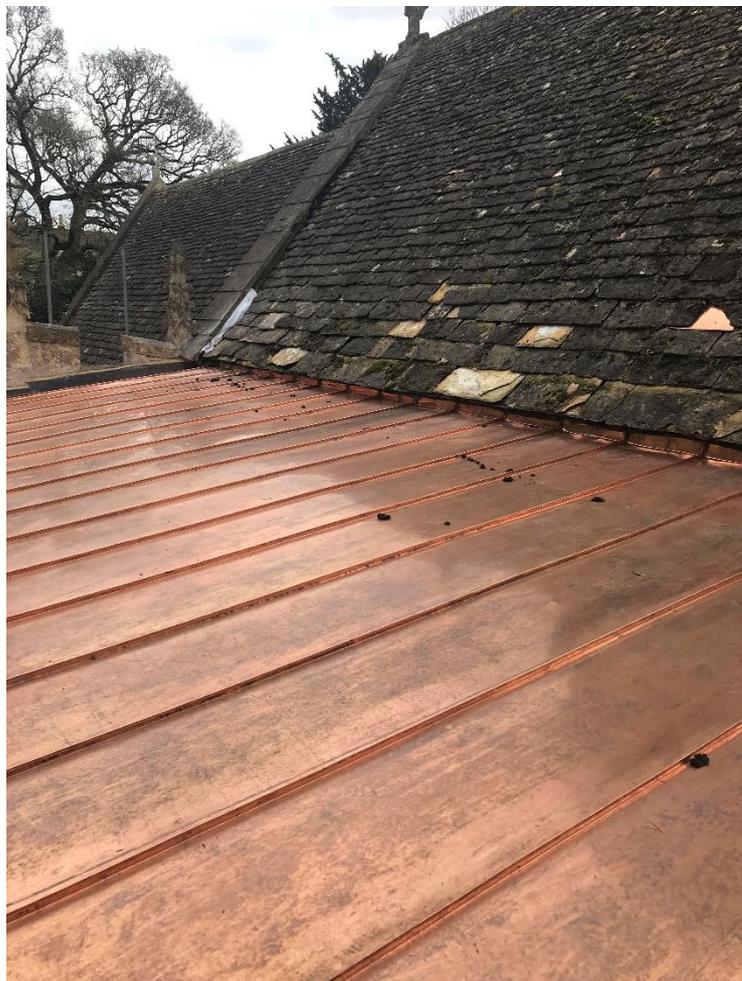
The North Aisle of St Peter's Church at Langley Burrell was originally covered in a stepped copper roof, over time the standing seams and step had started to allow water ingress. This was largely due to poor seam seals. A new copper covering was agreed, without the need for a step midway along the roof's length, therefore reducing the joints across the length of the roof.

Once the original copper was stripped and the lower 3 courses removed from the stone tiled roof. The new box gutter and outlets along the North parapet wall were replaced using sandcast code 8 lead. The copper bays were then formed in our yard and the entire roof was taken to site via a pickup truck. This was made possible due to the material being considerably lighter than lead. The timber substrate was repaired along the upper deck and the lower deck was lifted to give the roof a single continuous slope using European Redwood boarding. The new copper was laid on a breathable underlay that helps reduce rainfall noise. The copper bay seams were welted on site by our hard metals team. A Nicholson AirTrack vent was placed along the stone tile eave and the stone tiles were relaid. The flashings around the outer edge of the roof and gutter were replaced using lead.
