Case Study

St Thomas Church, Easton in Gordano

Roof and masonry conservation

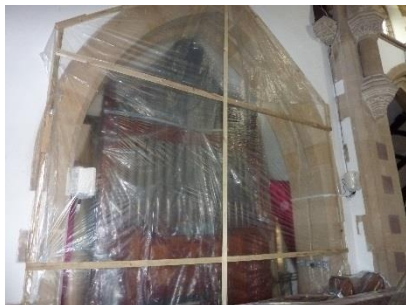
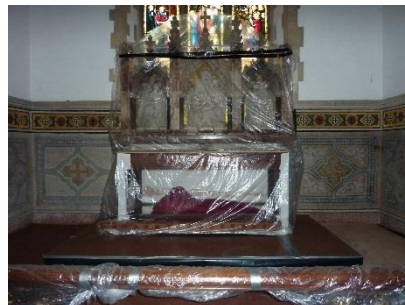
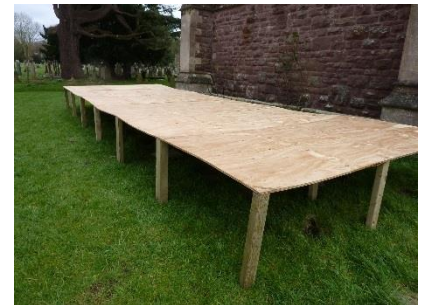
Internal ceiling works before, during and after.

Works included stripping slates, repairing the lead gutters with a mastic liner to reduce cost and risk of lead theft, and the installation of overflow channels. We repaired roof timbers and reslated the nave and chancel roofs. We repaired lathing in the crumbling ceilings, installed rock wool thermal insulation and replastered the nave and chancel ceilings and walls with traditional horse haired lime plaster and lime wash finish.

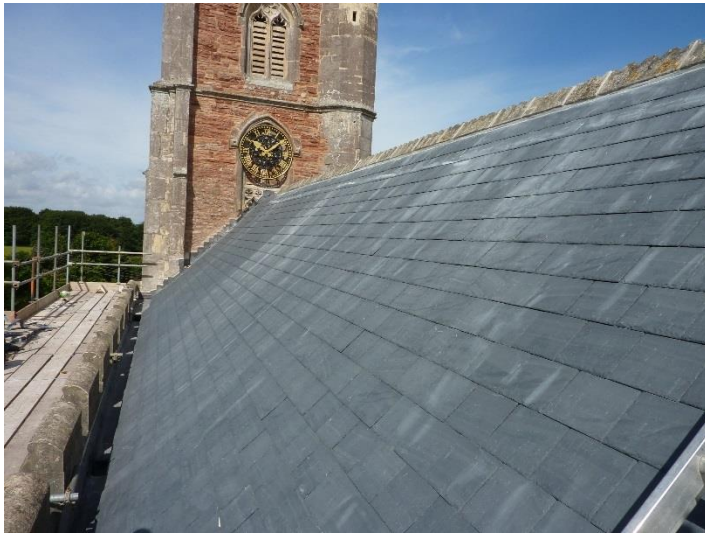
Mastic gutter shown to the left, alongside the reslated roof in welsh slate tiles, many of which had been sponsored by parisioners in support of the re-roofing project. Right shows the refurbished rainwater goods and newly installed overflow channel.
