# Case Study

## Holy Trinity Church

### Bradford on Avon

**Major re-ordering, flood proofing, an extension, drainage and full M & E package.**

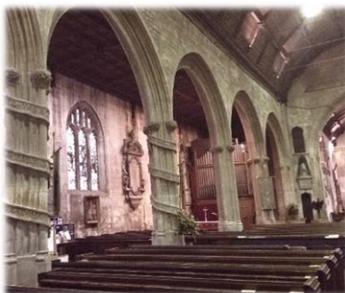
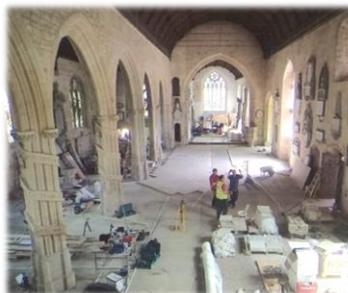
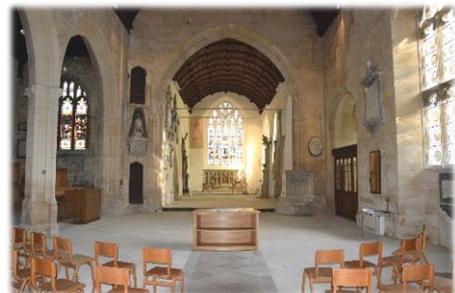
Before, during and after completion of the works – a fresher cleaner space suitable for community events and resilient against flood risk.

The reordering included installation of a kitchen, servery, toilets, meeting rooms, a new mezzanine level, a new build extension and improved access. A full M&E package included electrical, gas and plumbing. We appointed subcontractors to rewire the electrics and lighting with underfloor steel channelling and above floor mineral insulated cabling discretely positioned around the church stonework. We removed furniture and architectural features for restoration while the floor was excavated and raised, underfloor heating installed and a decorative Portland stone floor laid. Walls and masonry features were cleaned and repointed.

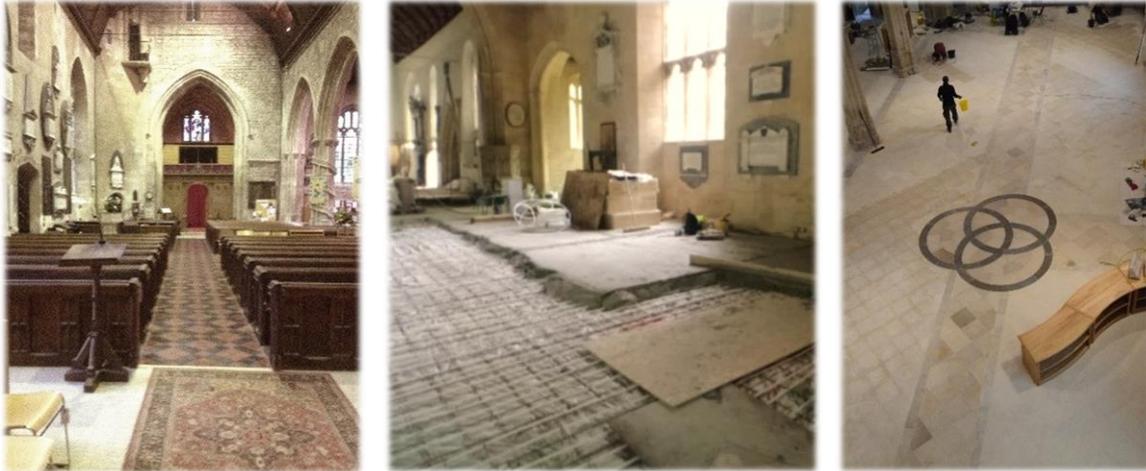
*(left) Before (middle) during the works (right) near completion – pews and monuments removed floors excavated and new floor laid.*

A trial section of floor was excavated to identify the make-up of the Victorian build. Concrete was removed and the floor raised and re-laid with beds of sand, hardcore, a geogrid of pipework, geotextile and new natural limestone stone flooring over a lime mortar bedding.

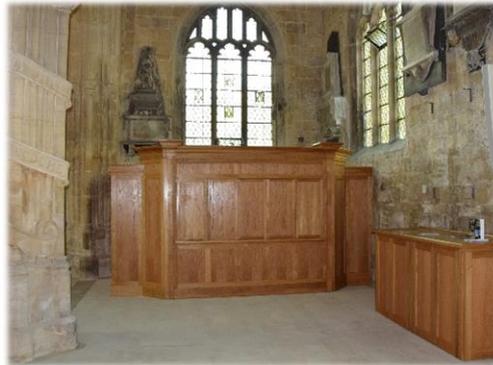
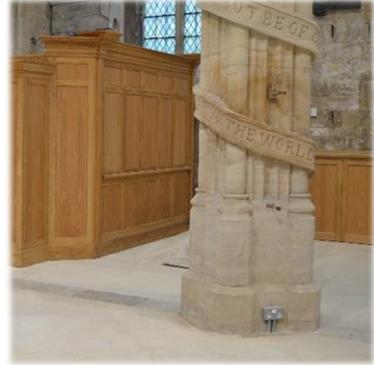
We extended space in the tower with a new mezzanine level, oak staircase and glazed screen.

Tailor made joinery items were created in our joinery workshop and fitted including a servery and toilets, cupboards, radiator covers, and a new welcome desk in addition to oak staircases and balustrades leading to the new mezzanine level.
