Case Study

Private Client, Bruton

Restoration of Entrance Gates

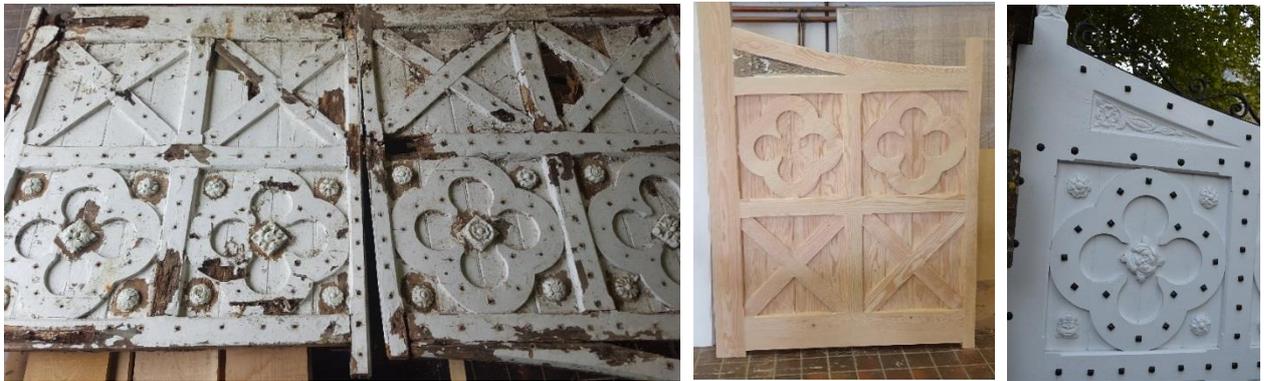
We replaced boundary gates at a private clients' property in the conservation area of historic Bruton, in Somerset. The original decorative entrance gates had suffered from weathering, high levels of rot and decay. The gates were taken to the Ellis and Co Joinery Workshop in Shepton Mallet for assessment and salvage. Where possible decorative items including carved rose details and finials were retained and restored. Iron studwork was carefully removed and retained for reinstallation in a newly carved set of gates.

Before (left) the rotted gates. (middle) the newly constructed gate structure (Right) with the addition of recovered decorative details and studs, repainted and rehung.

The new gate post and gate structures were created in our workshops using Douglas Fir to match the original designs. Carved details, finials and ironwork salvaged from the original gates were stripped of old paint finishes, refitted, and redecorated and the new gates rehung in stone gate piers at the property.

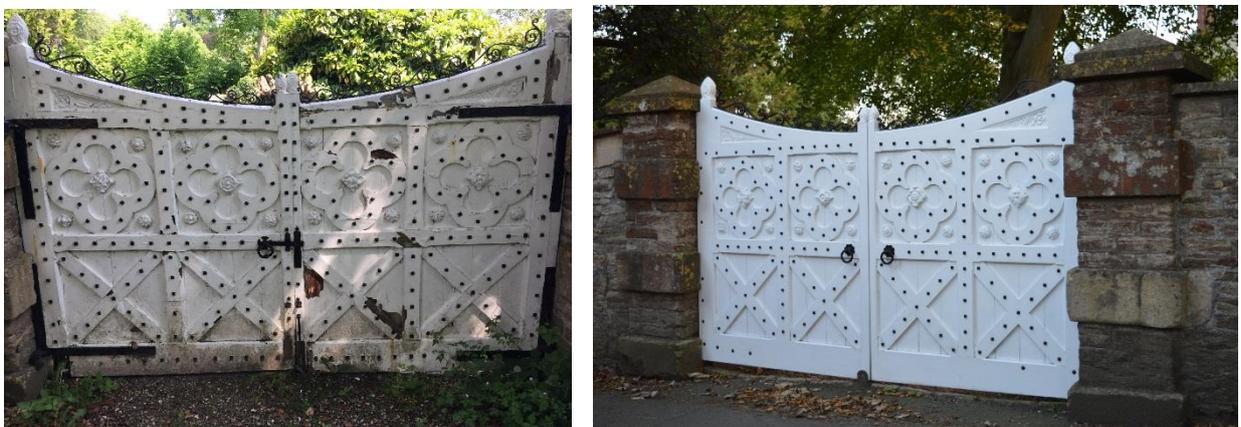
Before (left) the old rotted gates as shown above and after (right) after restoration.
