Church of St Gregory the Great, Cheltenham

The church of St Gregory the Great is a Grade II listed building consecrated in 1875 after a mid- 1800's rebuild. In 2018 Ellis and Co were commissioned as principle contractors for a project to extensively repair and redecorate the interior of the building. Internal high-level repair and redecoration of the church included the reinstatement of the original ceilings and high-level plaster in the Nave, Aisles, Crossings and Transepts. The Sacristy link and outer sacristy were re-ordered with new flooring, radiators and cupboards. A new lighting scheme was installed. Historic painted details were restored.

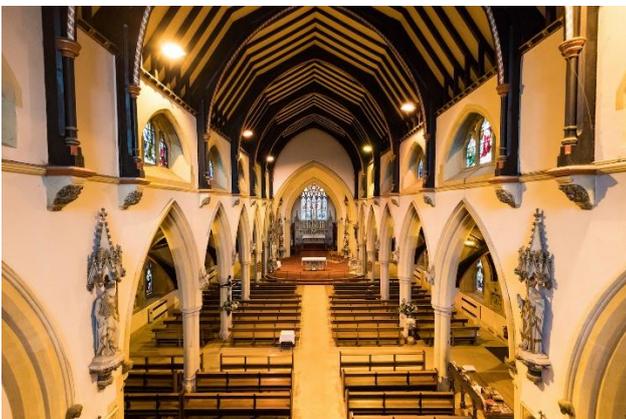
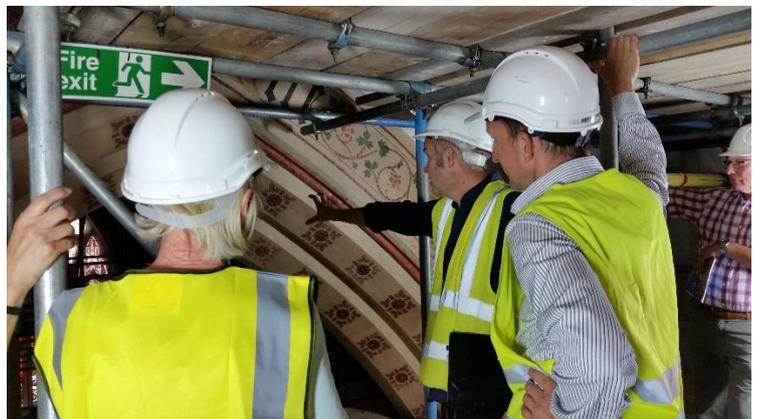
Images - Before the works (left). And during a SPAB members visit to view the uncovered paint detailing (right).

Further detail of the works included specialist conservation cleaning to remove 1970's overpainting of original 1800's decorative paintwork. Specialist conservation painters Perry Lithgow were brought in to uncover the original detailing hidden under 1970's lime render and to retouch paintwork throughout the church.

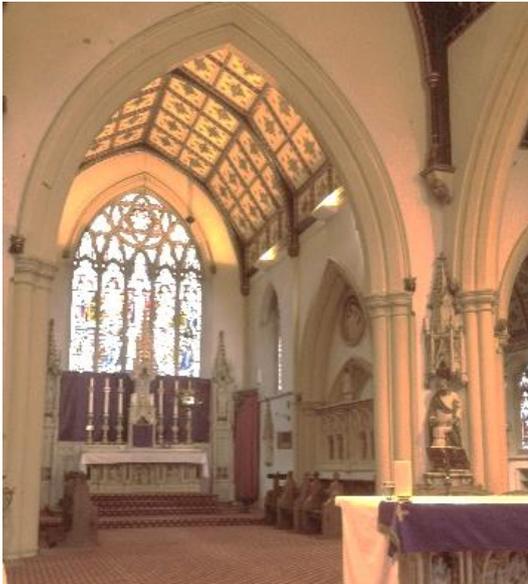
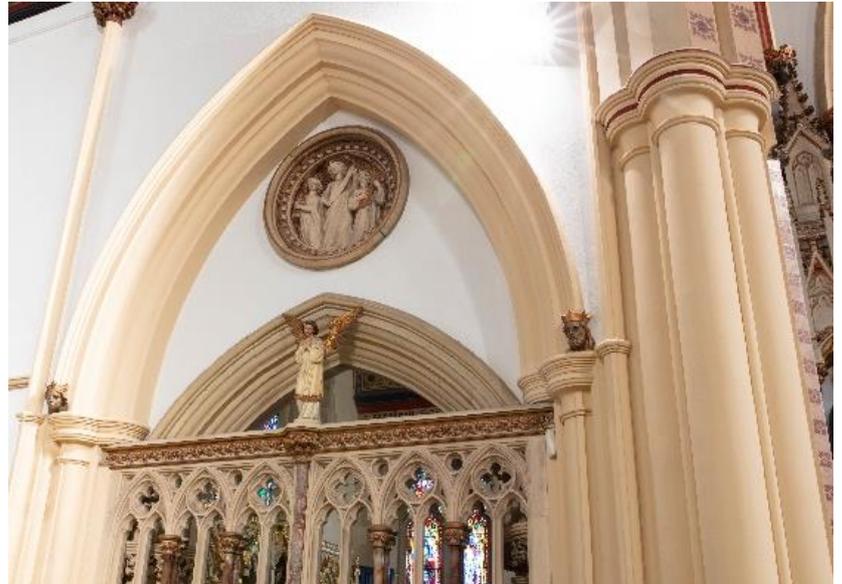
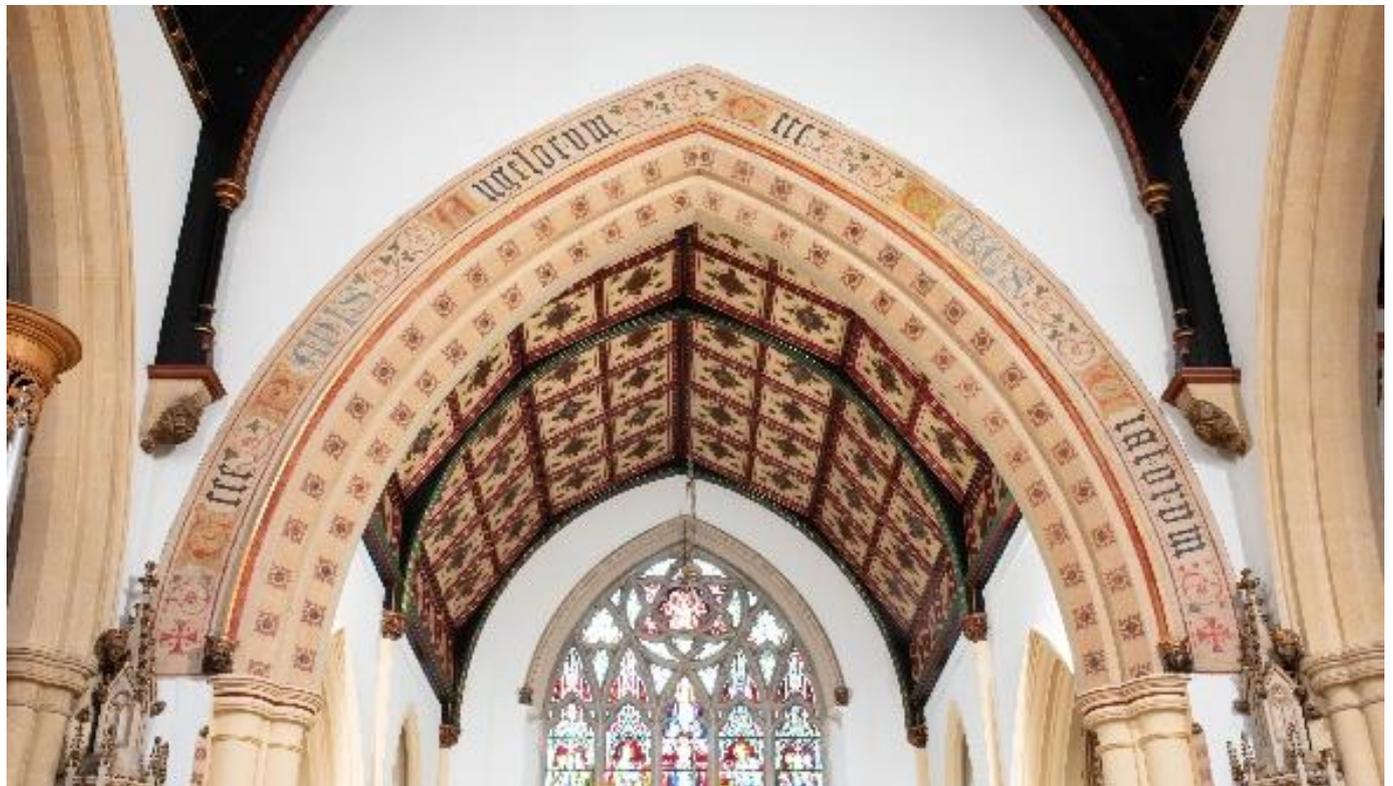
Ellis and Co masons repaired to surrounding masonry and repointed joints to the tracery. Badly stained masonry was subject to conservation cleaning. Samples of mortar and stone were approved by the architects before installation and the new Bath stone selected for masonry repairs was hand-tooled and dragged to match the finish of the existing stonework. A protective sheltercoat was applied to the Bath Stone and defective lime plaster was repaired, replaced as necessary and repainted.

The original ceiling was reinstated and its timber surfaces were repaired and re-varnished. The church floor was relaid. Old red carpeting was removed and the parquet floor repaired. New carpet was laid and tiles to the sanctuary and re-finished floor boards to the Sacristy were finished with oak detailing and trim.

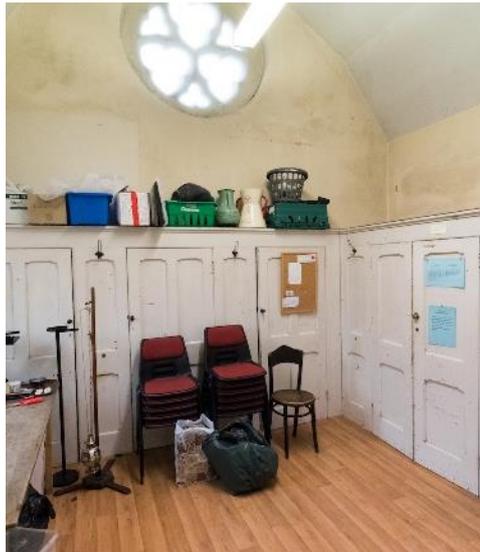
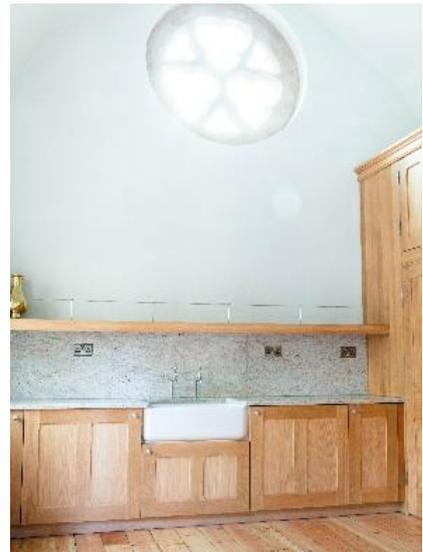
Before and after images of the new kitchen (left) and the new hallway storage (right).

Ellis and Co joiners and carpenters created bespoke oak furniture to replace tired cupboards.

Mechanical and engineering work included the replacement of main and emergency lighting, installation of and electricity and plumbing and heating to the sacristy including new radiators and creation of a kitchen space.
