Case Study

St John the Baptist Church

Pewsey

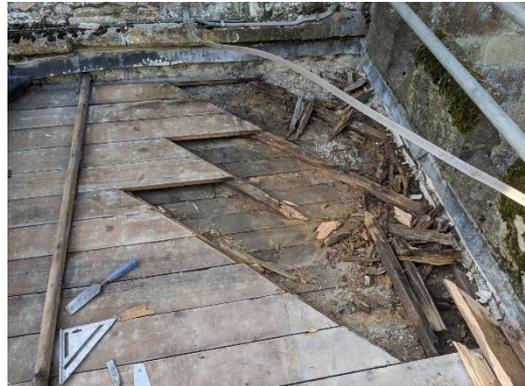
A recent lead theft from St John’s Church in Pewsey gave the church a difficult dilemma, do they replace the lead with another lead roof and fit alarms and security to help prevent further vandalism or should they rethink the roof covering and recover the aisle roof with terne coated stainless steel? Churches are particularly vulnerable to this type of crime with lead roofs proving a desirable target for a thief, with many roofs not being visible from the ground the damage caused by a theft can remain undetected for some time and can lead to major problems with water ingress to the building. The damage and expense caused to a local community church can be colossal and the depletion of church funds can leave a heritage building vulnerable to further damage as routine maintenance is forgone to replace a stolen roof.

The roof structure at Pewsey had suffered some timber decay and repairs were necessary. The rotten original boarding was removed and replaced with new redwood timber. Terne coated stainless steel (TCSS) was decided on for the new roof covering. To give a similar appearance of the original lead roof, it was decided to use a roll detail instead of a standing seem, this gives the appearance of a typical lead roof bay connection detail. The timber rolls are cut with a 45° angle on the end and are screwed to the

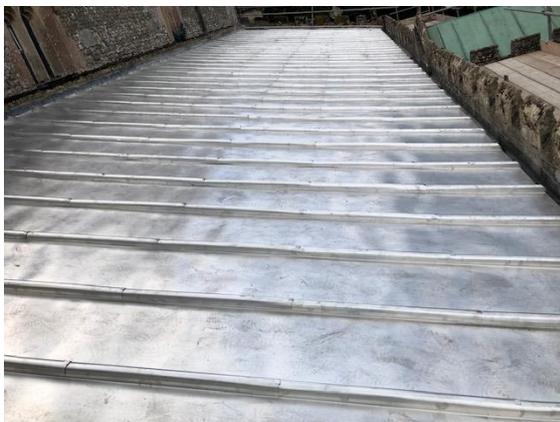
roof deck in the same way they would be on a traditional lead covered roof. The TCSS roll coverings are manufactured to give watertight seal between the bays. The bays for the Pewsey project were measured on site and manufactured in our workshop in Shepton Mallet. Due to the considerable weight saving, these could be transported using a van.

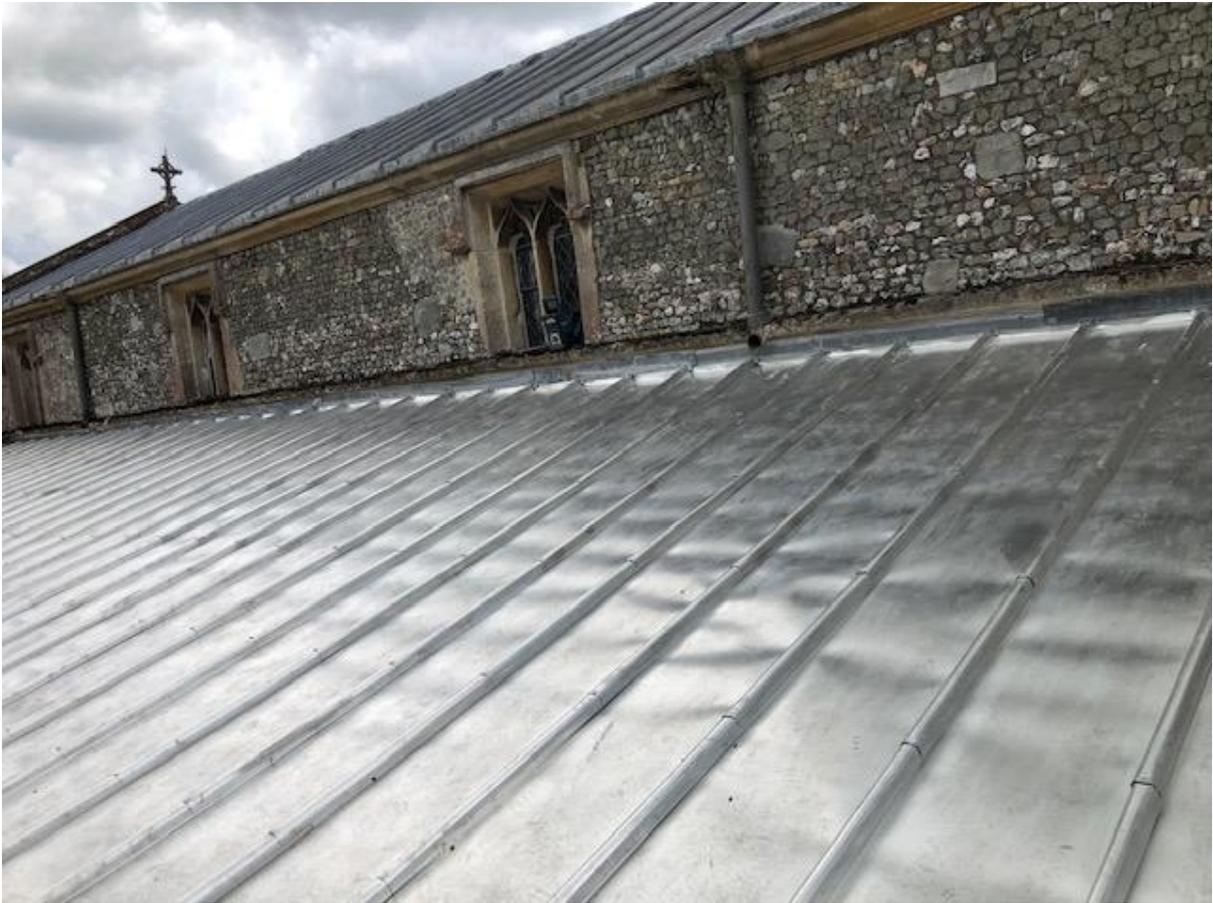
Our hard metal team proceeded to lay the roof bays in accordance with the Federation of Traditional Metal Roofing guidelines (FTMR). A Metmat Underlay was used below the TCSS to help reduce rain noise; this is placed between the rolls. The flashing details

around the roof were redone using lead, this often gives better weather protection due to lead's versatility when overcoming awkward details. The lead gutter detail along the North parapet wall

remained in place during the theft, it was found to have been in good order and was checked and repaired accordingly.
