# Case Study

## Progress reordering St John's Church, Glastonbury

Craftsmen in the  
Conservation of  
Historic Buildings

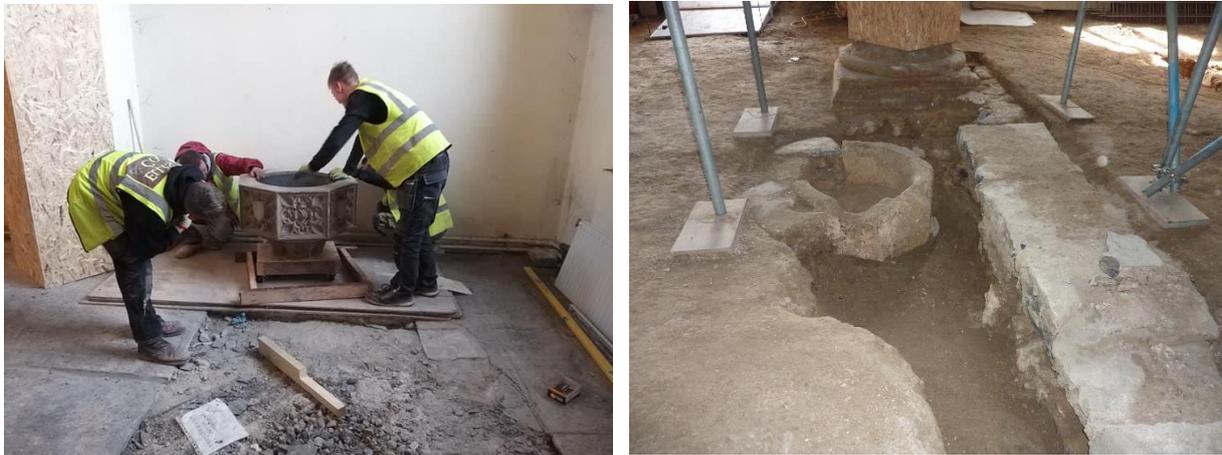
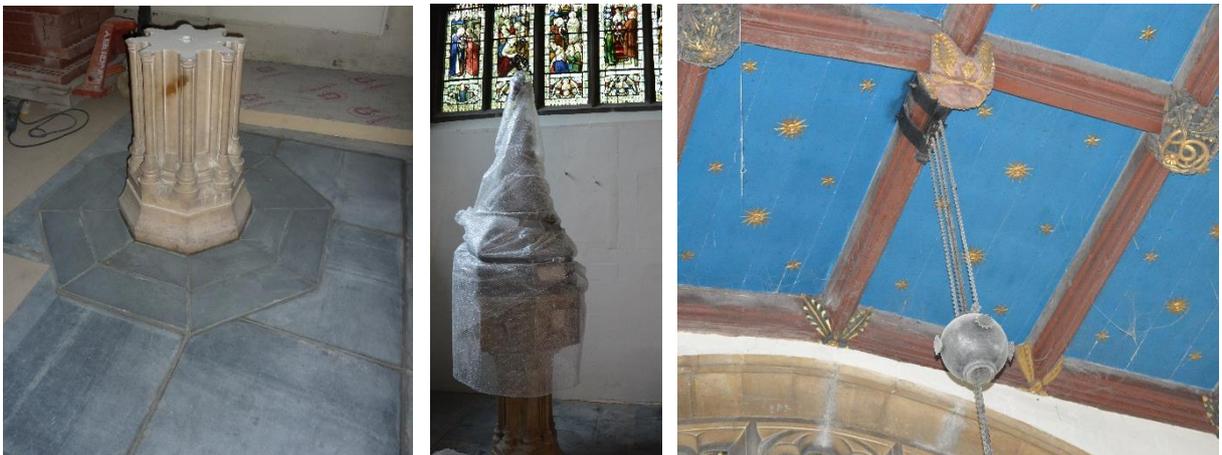
The Church's 14<sup>th</sup> Century font, is being brought back into use. It has been repositioned from the South West corner of the South Aisle to the Chancel in the North Aisle. It has been set on a new border base of blue lias stone and resituated on its plinth. The font hood has also been refitted.

A couple of surprising discoveries have been made during these excavations. Firstly a 13<sup>th</sup> Century font was found buried under its 14<sup>th</sup> Century replacement in the South Aisle. The original font design had clearly informed its 14<sup>th</sup> Century replacement as we see the same carved design in both. This

earlier medieval font basin had been broken on one side. The 13<sup>th</sup> Century font has now been recorded and reburied at the church as is tradition.
