Case Study

Halton House, Aylesbury

Conservation and repair of the Belvedere Tower.

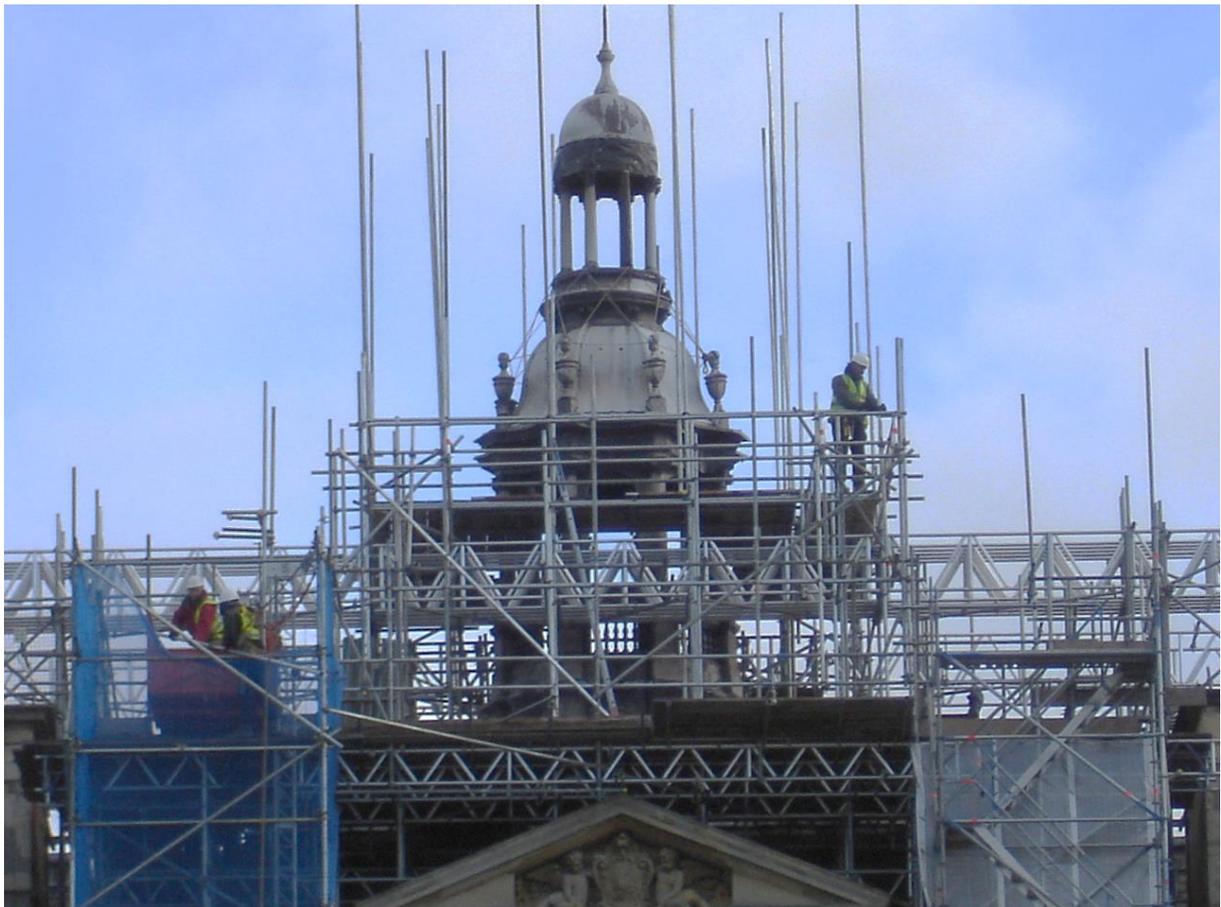
The original Belvedere Tower. The whole structure was removed, repaired and rebuilt and craned back into position.

Samples of the original wrought ironwork structure were analysed to identify methods of construction and the condition of materials. A new galvanised steel structure was built in sympathy and incorporating original materials where possible. Our joiners used reclaimed timbers to rebuild the roof and seasoned battens to build the tower structure. Original wood ornaments were repaired and where necessary replacements were carved. Our lead workers worked with English Heritage to assess the decorative leadwork and where necessary pieces were recast. When complete, the whole structure was craned back into place, secured, and the staircase leading through building and into the tower was restored. The roof was re-leaded and the beautiful iron-railing fall barrier was restored and repainted.

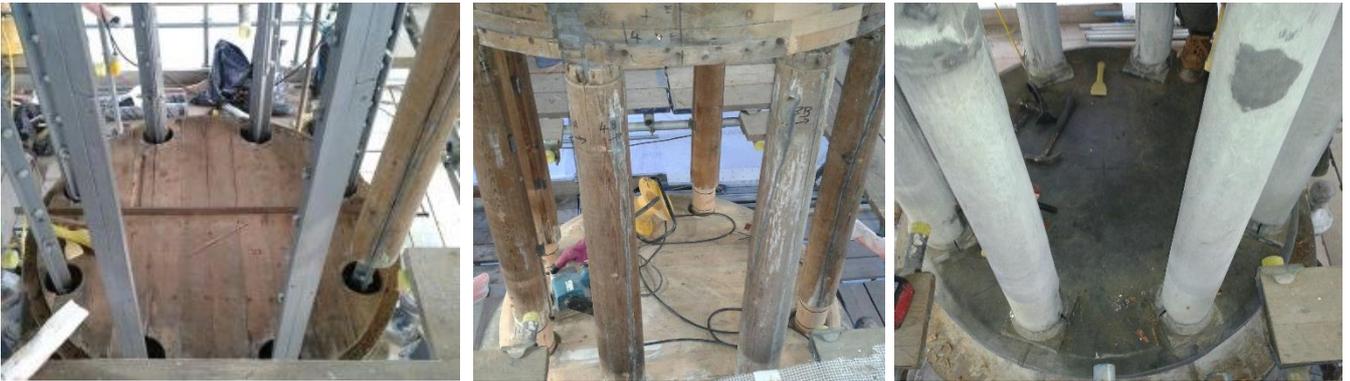
A new steel frame was commissioned to replace the perished ironwork Belvedere structure. This was craned into position, clad in timber, using original restored timbers where possible alongside new inserts, and then covered in lead in accordance with the original design.

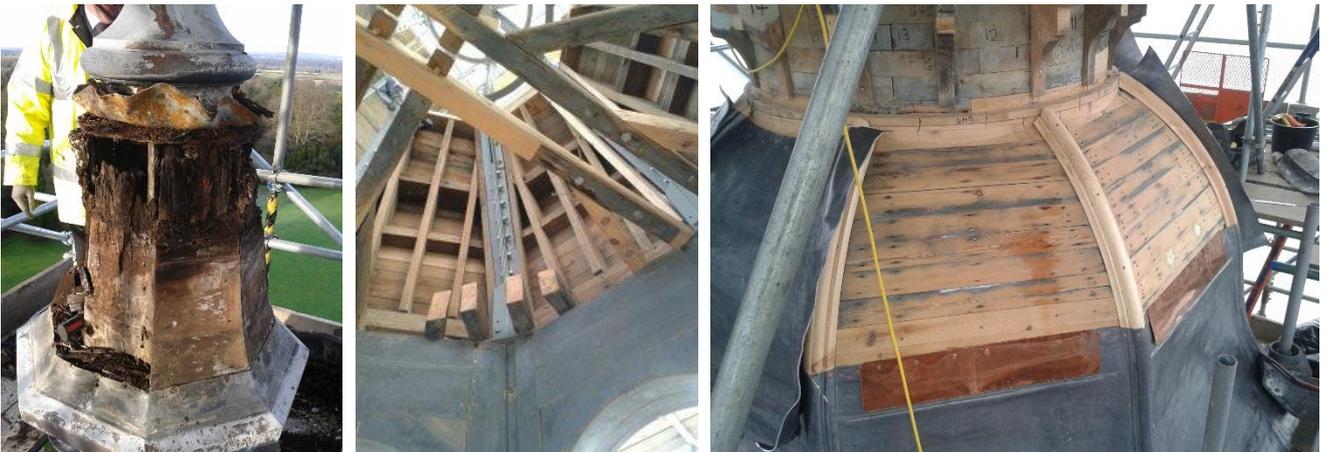
Lead and wood was eroded throughout the structure. What could be preserved was, and reclaimed wood was used alongside new materials to recreate the Belvedere wood clad and lead coated structure.
