St. Giles House

Wimborne St. Giles, Dorset

Brickwork conservation and new build

Stonework conservation and repair

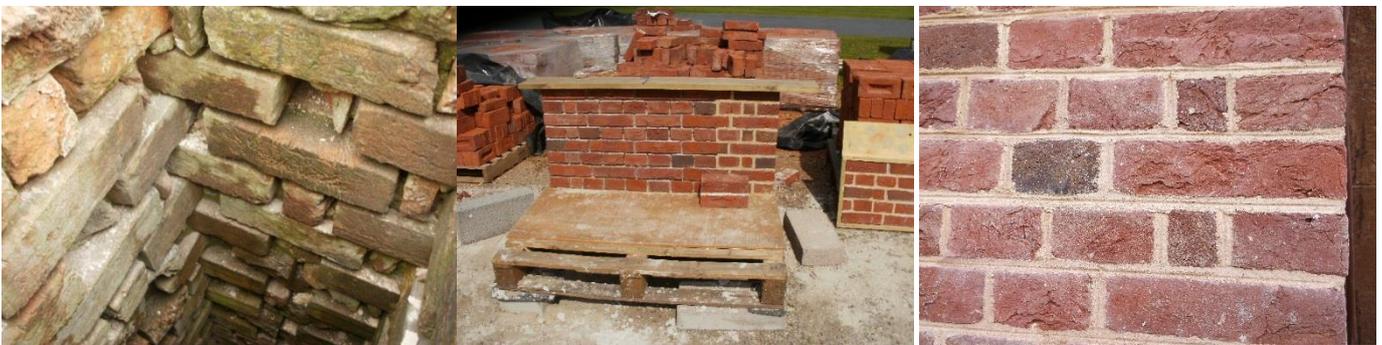
From left: The poor state of repair of brickwork. Commissioned bricks designed to match Renaissance originals in texture and colour. In situ in the new Loggia

The brickwork of this elegant Grade I listed renaissance building has been extensively repaired and repointed. Original 17th Century brickwork, and historic repairs, have been blended seamlessly with new materials. We used samples of original brickwork from St Giles House to create bespoke replacement bricks matching the colours, tones and textures of original brickwork. These were used in sympathetic repairs throughout the old building and laid in English Bond in the construction of the stunning new Loggia and apartment attached to the North Wing.

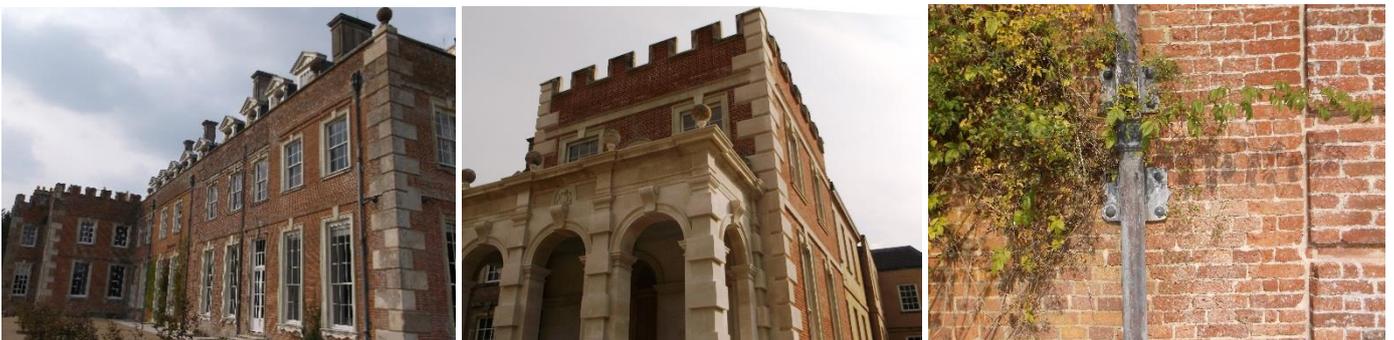
From left: The restored South Façade. The new build loggia and apartment. Seamless repairs and coloured pointing work on the weathered South Wing

Brickwork on the South Terrace, already damaged by the removal of 1820's render in the 1970s, had borne the brunt of weathering from the sun and rain. Where necessary perished bricks were repaired or replaced. A careful blending of coloured pointing was used to create an even appearance to the edges of the weathered brickwork, both preserving the original materials, blending in replacement bricks and creating a consistent appearance with less weathered sections of brickwork.

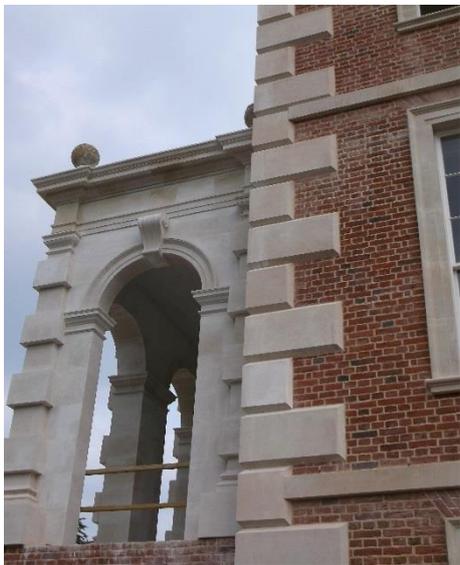
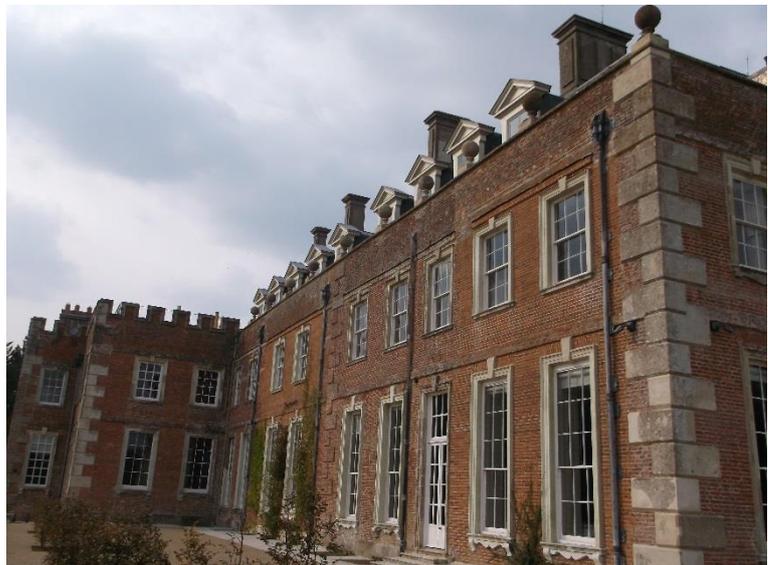
From left: The new loggia replicates the north door and stone is married in with specially commissioned brickwork. The South façade demonstrates replacements, and repairs to edging stonework, window seals, window dressings, and ornamental features on the roof.

The classical façade of this Grade I listed building has been restored throughout. In the old building damaged stonework has been conserved and repaired. Only where necessary replacement materials have been introduced and crafted to blend with the original stonework. The new loggia and apartment continues the classical style using design elements from the original house. Here the Doric columns, edging stones and keystones have been carved from Portland stone by Ellis and Co's masons.

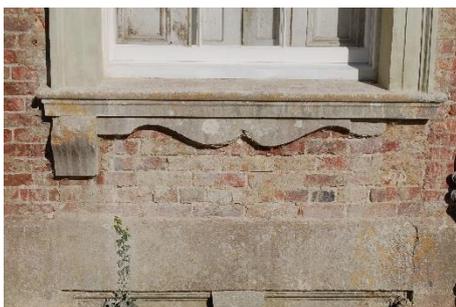
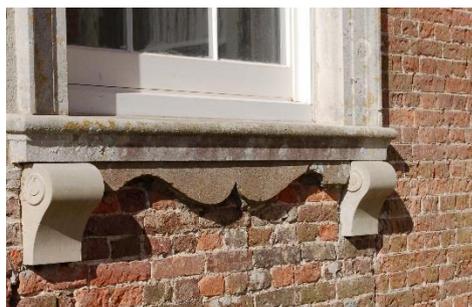
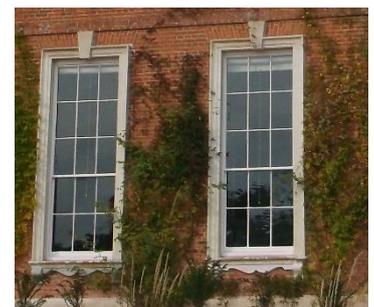
Stonework damaged through weathering and neglect has been sensitively repaired. The finished windows, right, show repairs to seals and dressings blend.

Throughout each wing of the house window seals have been repaired and replaced in part or in entirety using Portland stone. For the window dressing repairs we used Chilmark, an exceptionally high quality limestone from the Chicks Grove quarry. Mortar mixes were developed and selected to blend with original stonework.

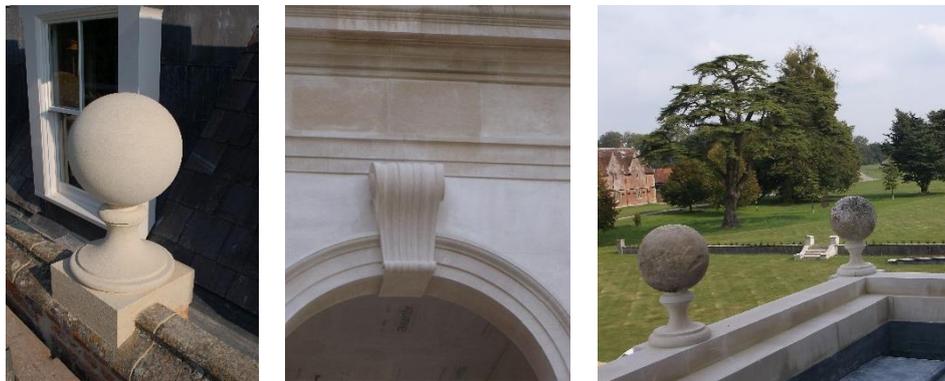
St Giles House boasts beautiful architectural features such as the balls and plinths that adorn the perimeter of the roof. These were removed for cleaning and repair, while the roof was replaced. Where necessary replacement replicas were carved and introduced alongside the originals.

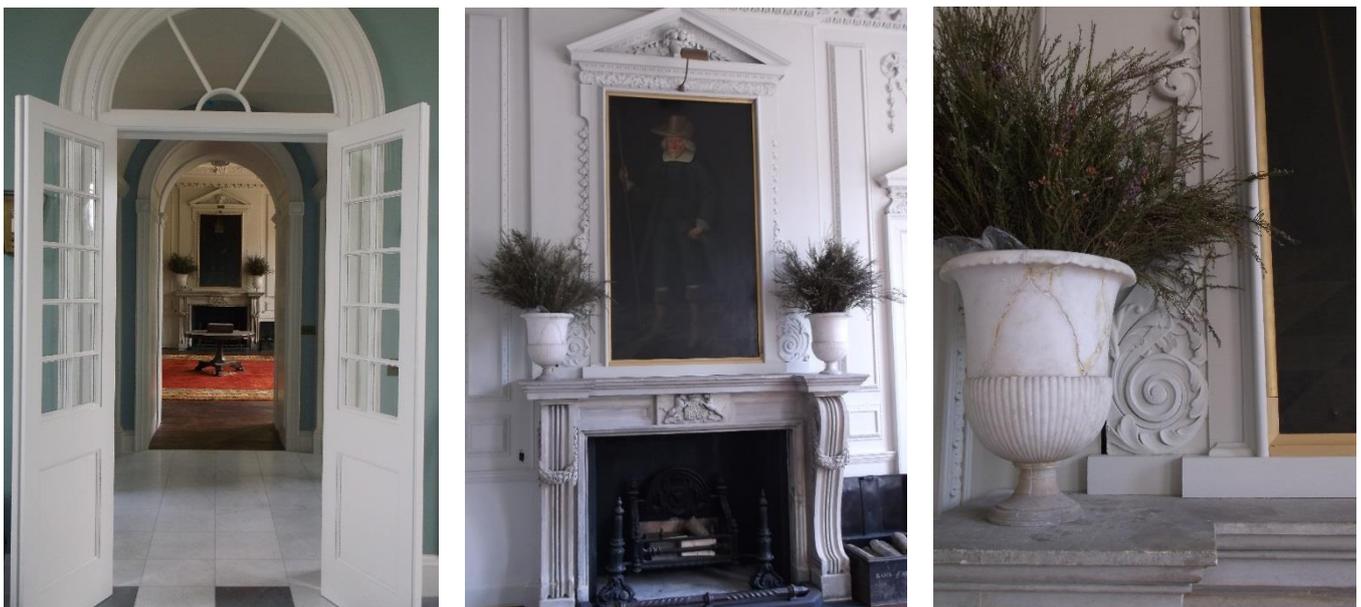
Detailed stonework is also a feature within St Giles House. For example, Ellis and Co craftsmen carved detailed ornaments which furnish the restored fireplace in the beautifully plastered 'White Room'. The marble floor of the loggia which leads into the white room makes an elegant entrance.
