Case Study

Salisbury Guildhall

A programme of internal redecoration and later a programme of roof repairs and M&E installations to this Grade II civic building.

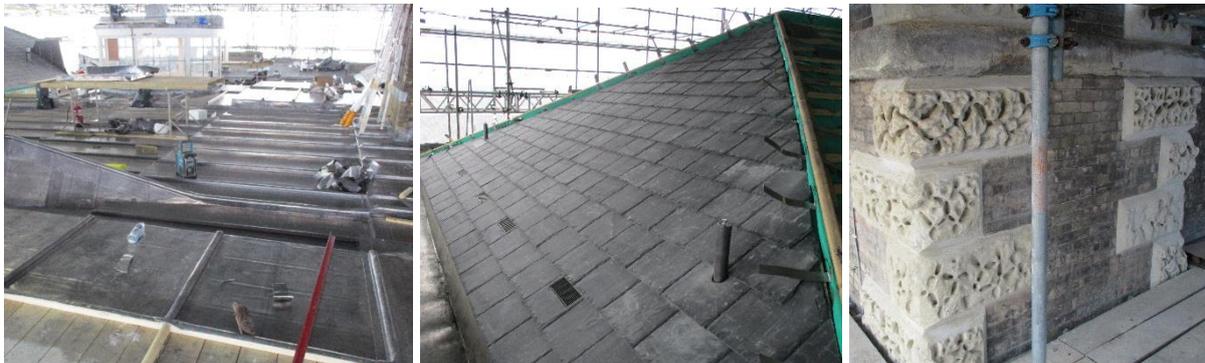
During the recent roof work, special photographic hording was commissioned to give a 'business as usual' feel to the building and the works were completed under cover. Two king post trussed roofs with slate coverings sit to the east and west with an expansive flat lead roof in central area over the main entrance. Leadwork was replaced including moulded details, access hatches and steps. We repaired and reglazed the two lantern rooflights. The slate roof was retiled using original slate where possible.

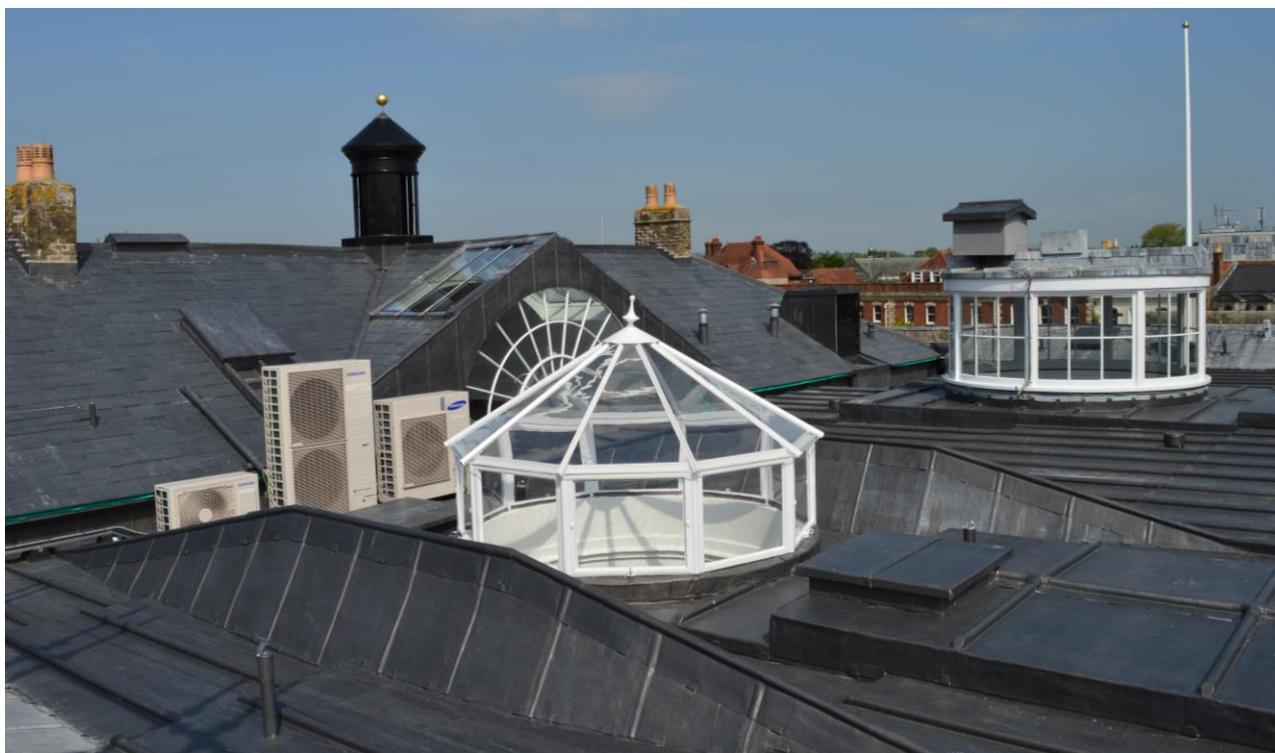
Brick supports for the bearings of the king post trusses were cleaned and consolidated. Ten common rafters that had dropped over the banqueting room were raised and secured. Common joists over the main entrance and decayed rafters on the north end of the roof were supplemented with new treated timber supports. During the works we installed protection to the ceiling of the Banqueting Hall to conserve any loose plasterwork from the original ceiling.

Asbestos roof slates were removed. We installed walkways in the ceiling voids, laid new lead on the roofs including detailed lead steps to the access hatch and introduced fall arrest, lightening conduction and bird management systems. We appointed subcontractors to install PV solar panels and an air conditioning system to manage humidity in the building. Our joiners repaired and redecorated the decayed rooflights, window cills and sashes and we redecorated the vaulted section of ceiling in the crown court.
