# Case Study

## St Marys Church

### Westonzoyland

**A programme of major repairs and reordering of this 15<sup>th</sup> C church has been completed including replacement of the nave roof coverings, external masonry repairs, repair of many glazed clerestory windows, provision of a servery, electrical services, internal repairs and redecoration.**

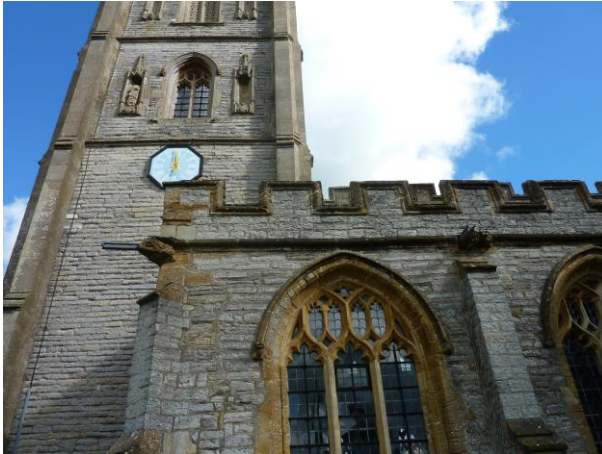
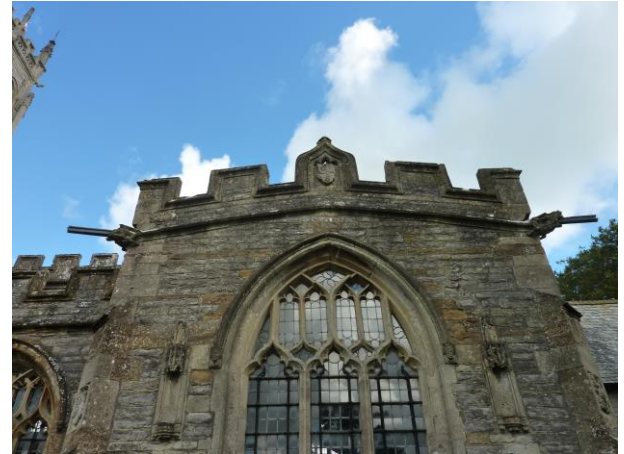
Defective masonry was repaired and where necessary replaced. Extensive mortar repairs have been made to the masonry, particularly around the clerestory windows where defective earlier repairs and ferrements were causing damage to surrounding masonry. Architectural features including crenellations, watershutes and gargoyles have been structurally pinned and repaired. Stonework has been cleaned of vegetation and sooty deposits with gentle brushing, a low pressure system and the application of poultices. A cleaning trial was undertaken before rolling out a wider programme of poultice work.
