Case Study

Halsway Manor, National Centre for Folk Arts, Crowcombe

HLF funded programme of repairs and redecoration.

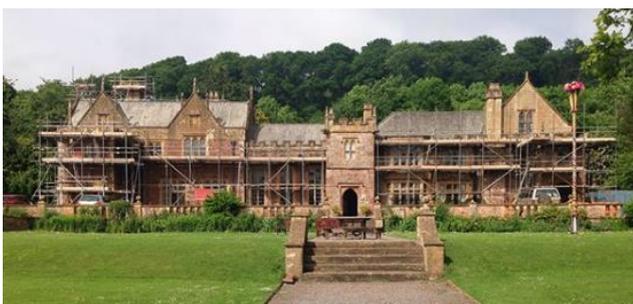
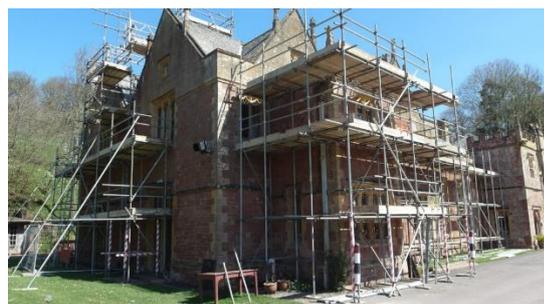
Externally we re-slatted the roof and repaired the chimneys and cast iron rainwater goods. Ladder brackets were installed for future access. Masonry repairs were undertaken including the removal of cement fills, repair of stone surrounds and stitching repairs. Doors and windows were repaired and redecorated. Glazing repairs were undertaken on broken panes.
