Case Study

St. Paul's Church Clifton

Re-roofing of a Grade II listed church on the Heritage at Risk register.

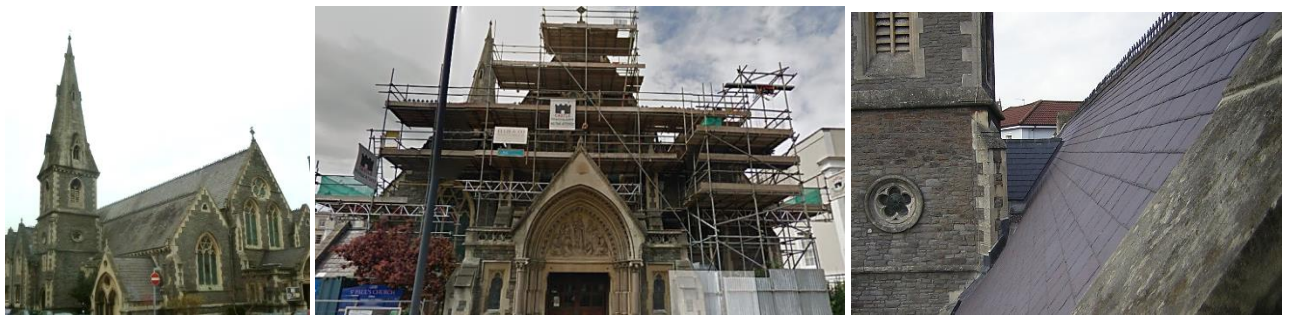
Slate roof tiles were removed, assessed, repaired where possible, and replaced alongside modern additions. New Welsh Penryn Blue Slates were chosen to blend with existing tiles in colour, size and texture. An alternative and cost effective Spanish Slate was used in less visible areas. Decorative ridge tiles which once adorned the roof crest were recovered, repaired and replaced thus restoring a classical Victorian feature.
