Case Study

St. Thomas' Church

Exeter

Re-roofing of a Grade II listed church on the Heritage at Risk register.

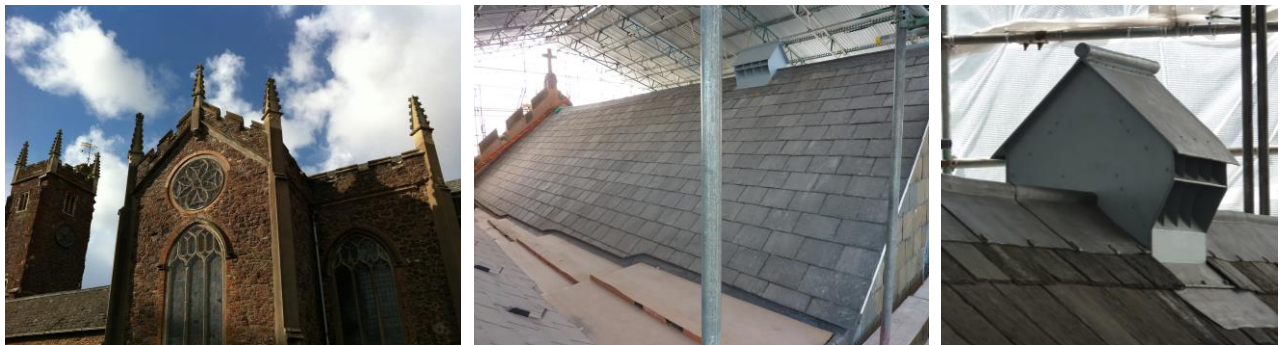
Ellis and Co completed a major programme of roof repairs to St Thomas's Church in Exeter. This Grade I listed Gothic church, some of which dates between 14th C and ca.1646 and with a north aisle of ca. 1810 and a chancel of 1829. It is the largest church in Exeter but severely affected by the ingress of water. Works included roof structure repairs, re-slating and leading the roof.

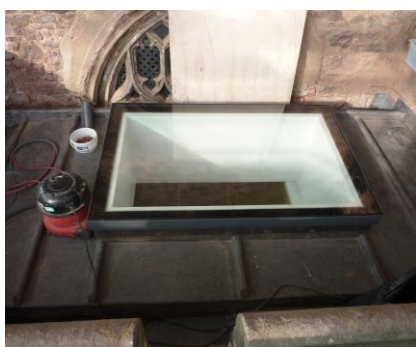
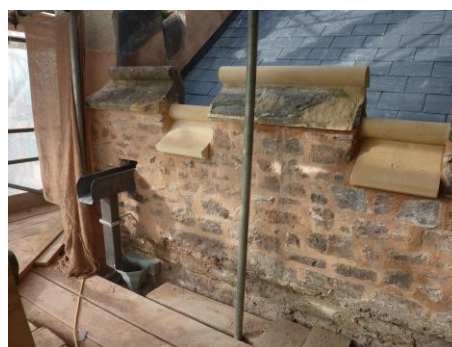
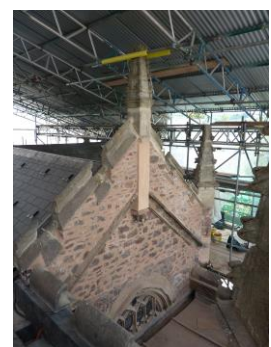
Roof slates were removed, assessed and broken ones replaced with welsh slate. Timbers were repaired, and a new flat roof was laid above the Lady Chapel. Water drainage iron hoppers and downpipes were fitted replacing inadequate plastic pipes. A custom rooflight was fitted, as were roof anchors for planned solar panels. Masonry was cleaned lightly using a poultice method and repaired and structural supports added where necessary. The parapet walls were rebuilt substantially on the east side of the transept.
