Case Study

Uvedales, Corfe Castle

Conservation restoration of Grade II listed 16th C properties on a National Trust Estate.

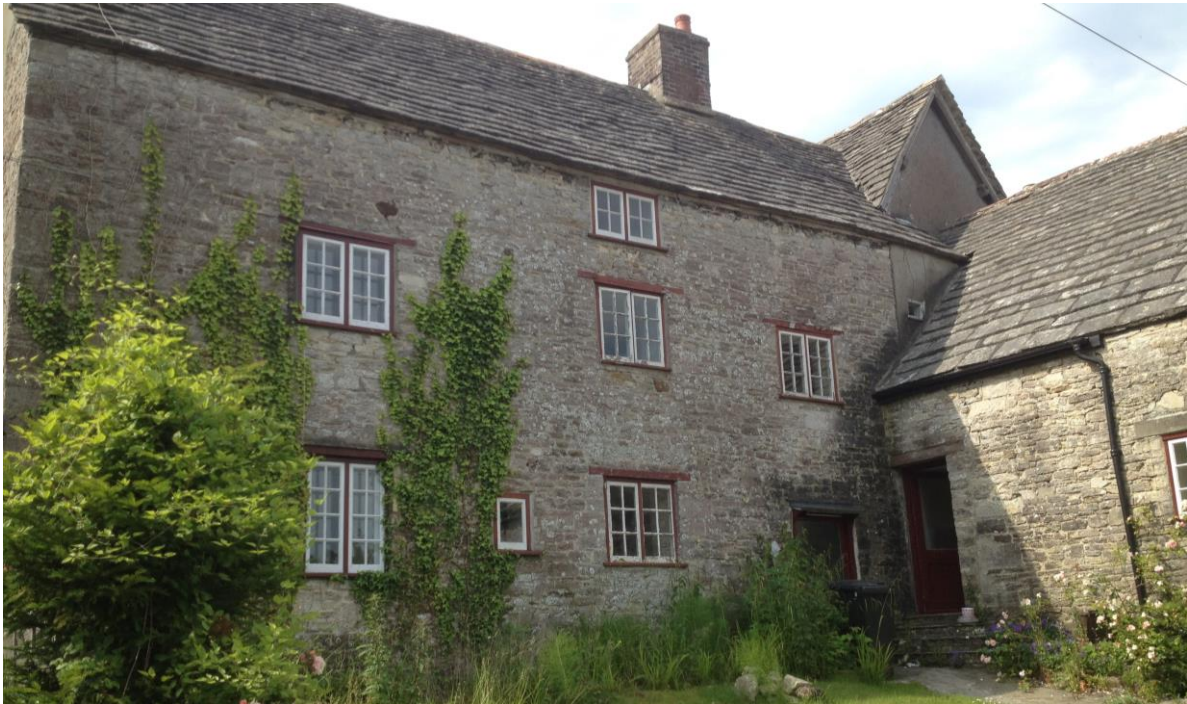
Grade II listed 16th C buildings of rubble stone walls, stone slate roofs and brick stacks. Originally a town house, converted into poorhouse in the 17th C and now part of the National Trusts Corfe Estate. In July 2016, under instruction from Philip Hughes Architects, Ellis and Co completed a nine-month programme of conservation restoration to transform the building from dereliction into four units of space suitable for accommodation.

Slate roofs were repaired and reslated with Purbeck slates from the Landers Quarry. Rainwater goods were renewed with new Ashworth iron downpipes. Exterior masonry walls and mullion windows were repaired and repointed. A new dormer window fitted. Windows and doors were repaired in situ where possible, others requiring more extensive restoration were removed and taken to the Ellis and Co workshops for joinery repairs. Additional secondary glazing was fitted to make the building insulated and sound proof. A dampproof membrane was laid. Cintec anchors were installed.

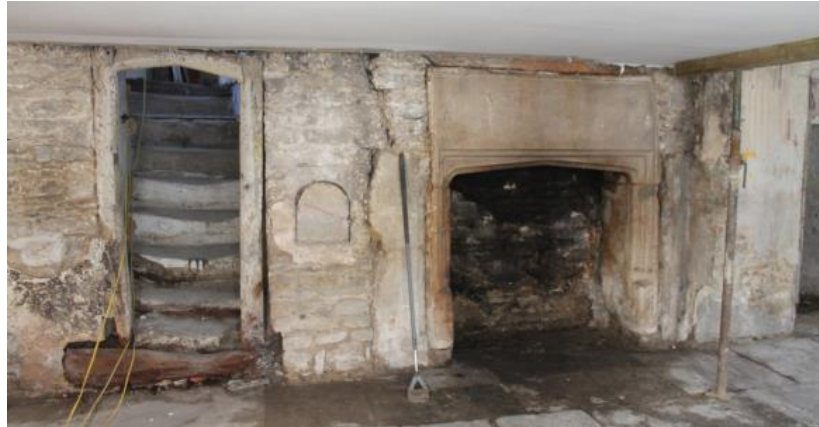
Historic timber floors were evaluated, areas of rot removed and repaired with salvaged replacement timbers. Flagstone flooring was also relaid over a dampproof membrane. Staircases were refurbished, one unsafe staircase was reinstalled in entirety.

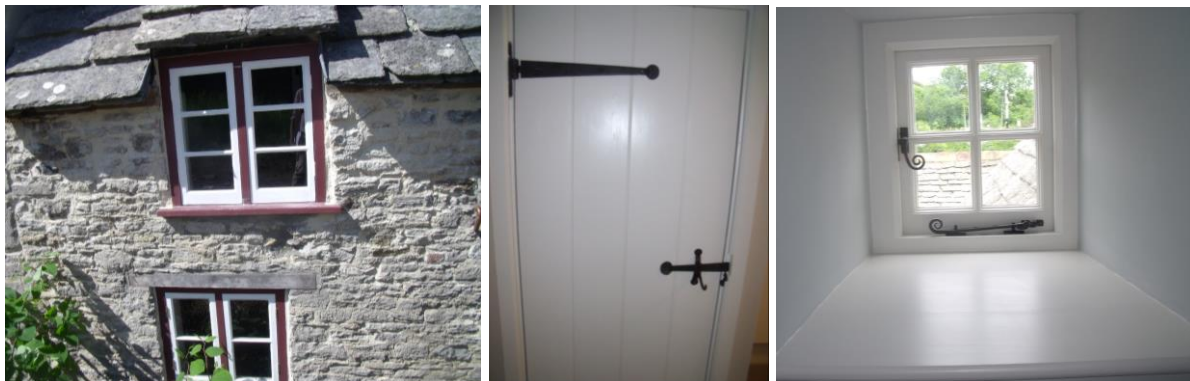
The restored doors, windows and lime rendered walls were decorated with a schedule agreed with the National Trust.

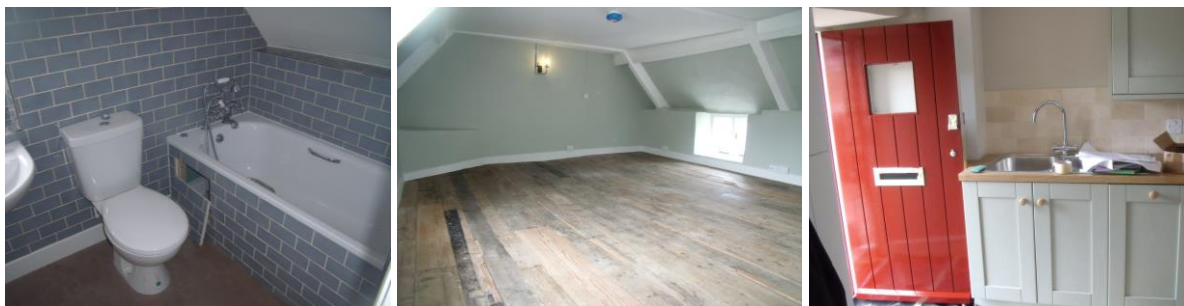
New services included complete rewiring, gas supplies, heating and hot water systems. Bathrooms were tiled and fitted, and kitchens with bespoke oak units were installed. Some walls were relocated to provide a new internal layout and a derelict attic space was converted into accommodation. Externally outbuildings were demolished, below ground drainage added and gardens landscaped, including a new driveway and parking areas.
