Case Study

Holy Trinity Church

Bradford on Avon

Major re-ordering, flood proofing, an extension, drainage and full M & E package.

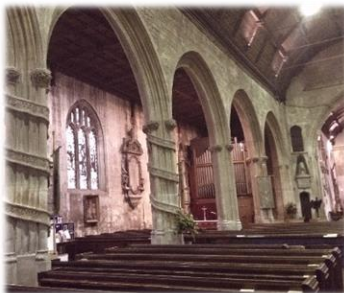
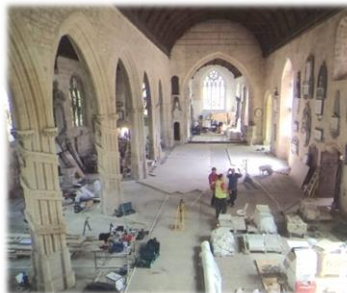
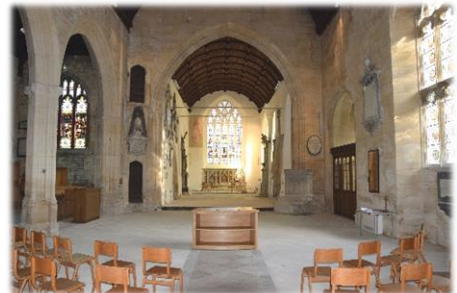
Before, during and after completion of the works – a fresher cleaner space suitable for community events and resilient against flood risk.

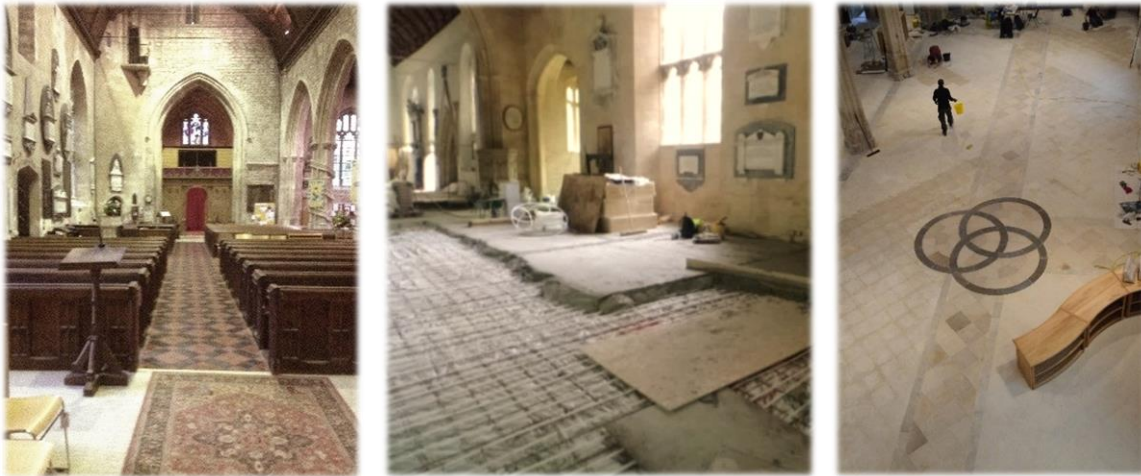
A trial section of floor was excavated to identify the make-up of the Victorian build. Concrete was removed and the floor raised and re-laid with beds of sand, hardcore, a geogrid of pipework, geotextile and new natural limestone stone flooring over a lime mortar bedding.

(left) Before (middle) during the works (right) near completion – pews and monuments removed floors excavated and new floor laid.

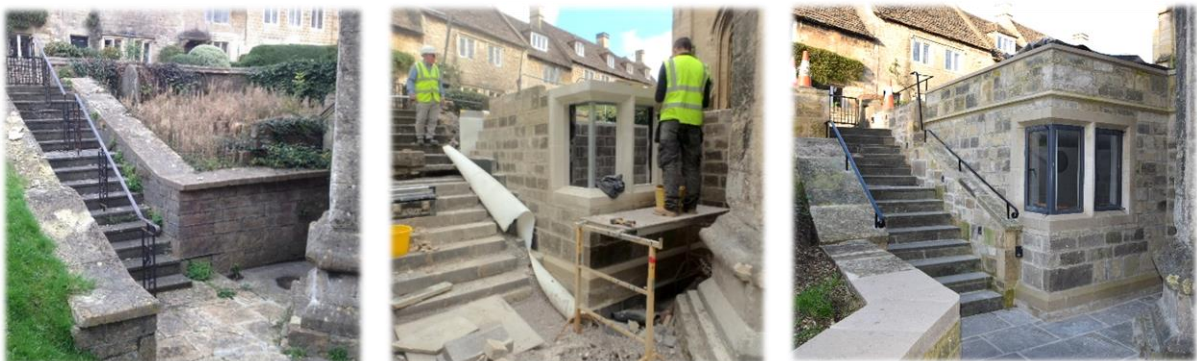
Externally, we built a small extension with fixed light windows, new drainage, a raised gathering area of pennant stone slabs, a disabled ramp of pennant cobble stones and a stone boundary wall of reclaimed rubble and bath stone copings.

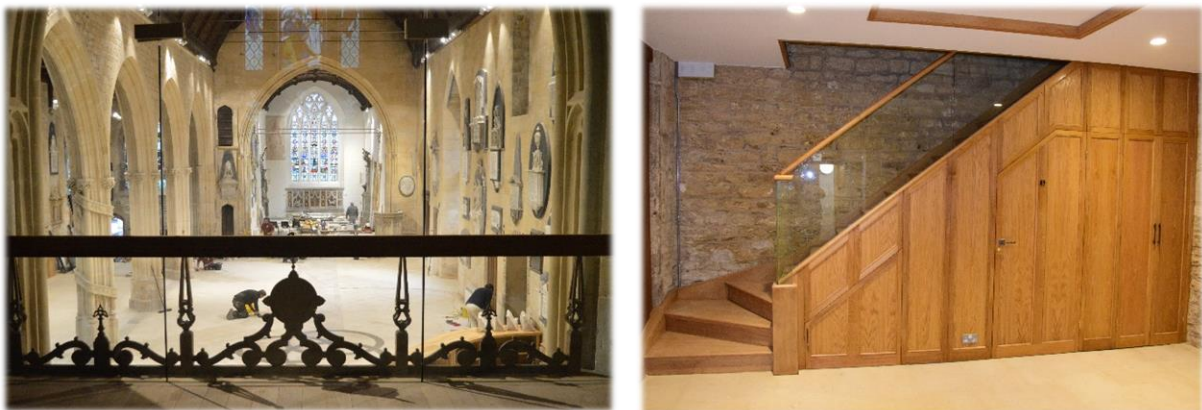
We extended space in the tower with a new mezzanine level, oak staircase and glazed screen.

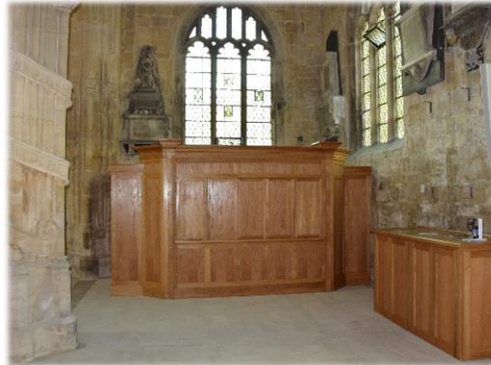
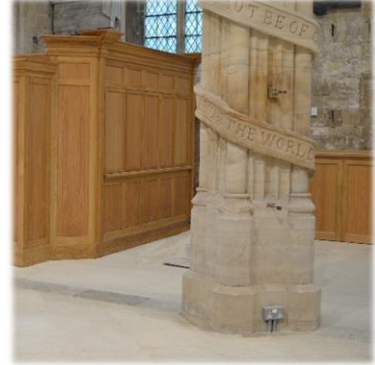
Tailor made joinery items were created in our joinery workshop and fitted including a servery and toilets, cupboards, radiator covers, and a new welcome desk in addition to oak staircases and balustrades leading to the new mezzanine level.
