Gloucester Cathedral

Project Pilgrim

Craftsmen in the
Conservation of
Historic Buildings

Major Internal Reordering. An additional roofing contract was completed.

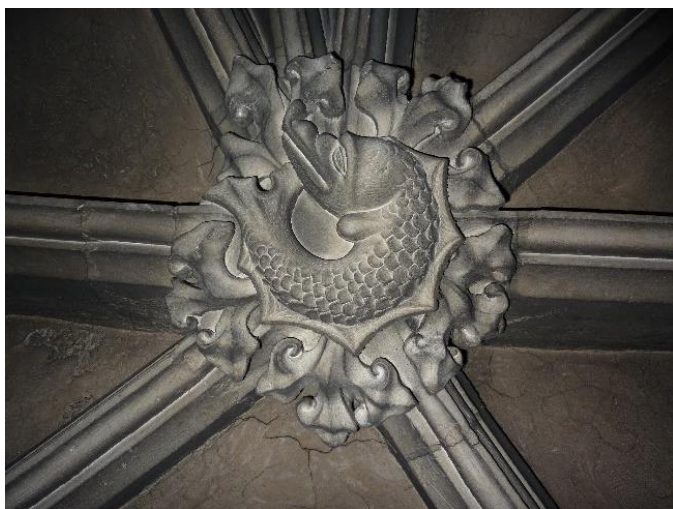
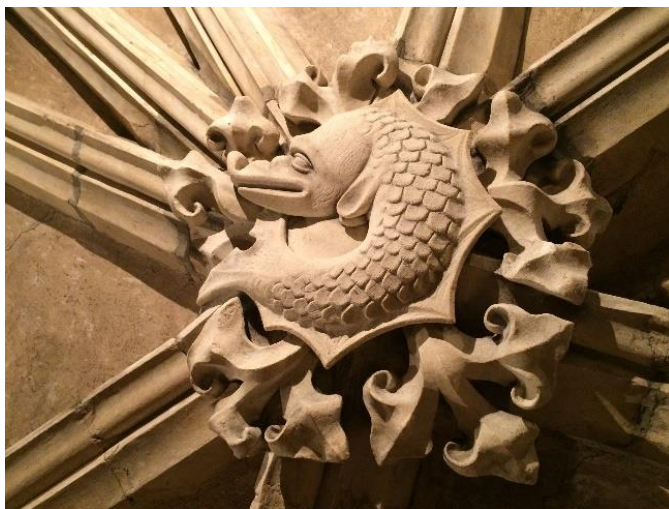
Top bosses before and after cleaning. Bottom glazing repairs and Cathedral project team inspection.

The font and Christopher Whall glass panels were removed to allow access during works. Extensive dry and wet poultice cleaning and conservation of stonework was completed throughout the Lady Chapel. Lime plaster repairs were made and walls limewashed. Alongside masonry repairs including to decorative stonework and windows this has created a more appealing appearance. Stained glass windows were clean by specialists and glazing repairs including replacement of copper ties and bars.

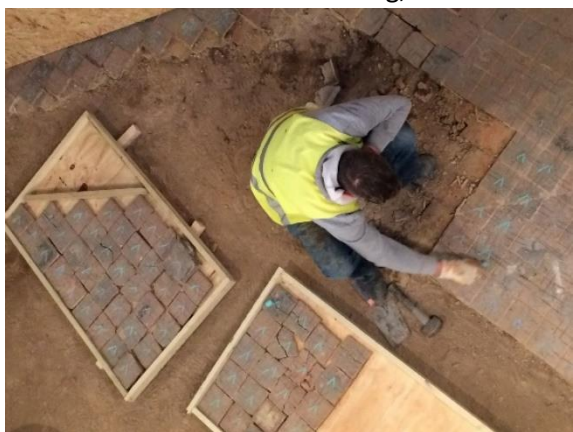
*(l) Lifting floor tiles and laying underfloor heating in the lady Chapel.
(r) Lifting the ledger stones.*

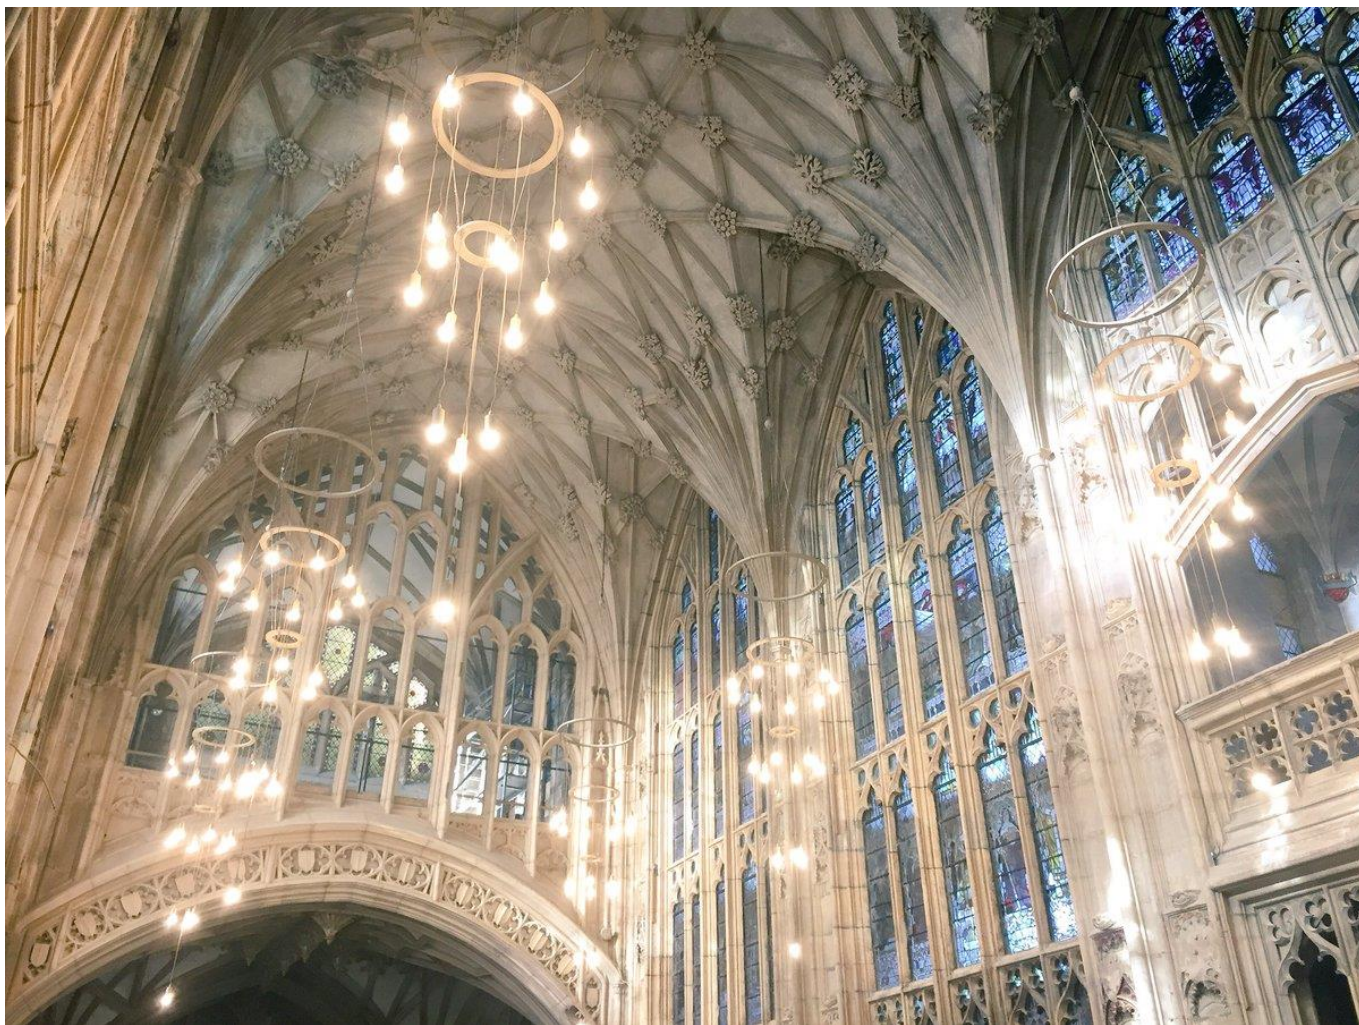
Above: Lighting installed in the newly cleaned Lady Chapel. Below: new glazed entrance lobby.
