# Case Study

## The Granary, Abbotsbury

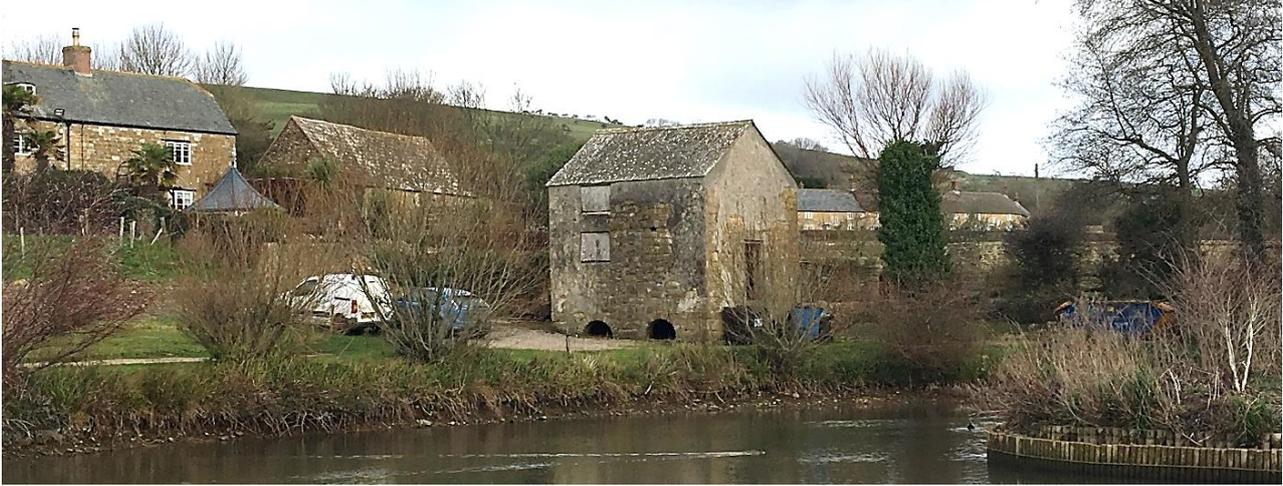
Ellis and Co completed a programme of structural stabilisation, repairs and restoration roofing of The Granary. This historic scheduled monument lies in the southern precinct of the remains of St Peters Benedictine Abbey at Abbotsbury. The two-storey granary structure is thought to date to the 18<sup>th</sup> Century and is built from 14<sup>th</sup> century masonry recovered from the original Abbey.

Asbestos in corrugated roof sheeting was removed by a specialist sub-contractor. The iron roof structure was removed to enable the reinstatement of a timber roof with double roman clay tiles.

The walls were cleared of vegetation and the masonry and lime stabilised. Temporary timber supports were installed while the walls were repaired with stone from the Abbey's own quarry.

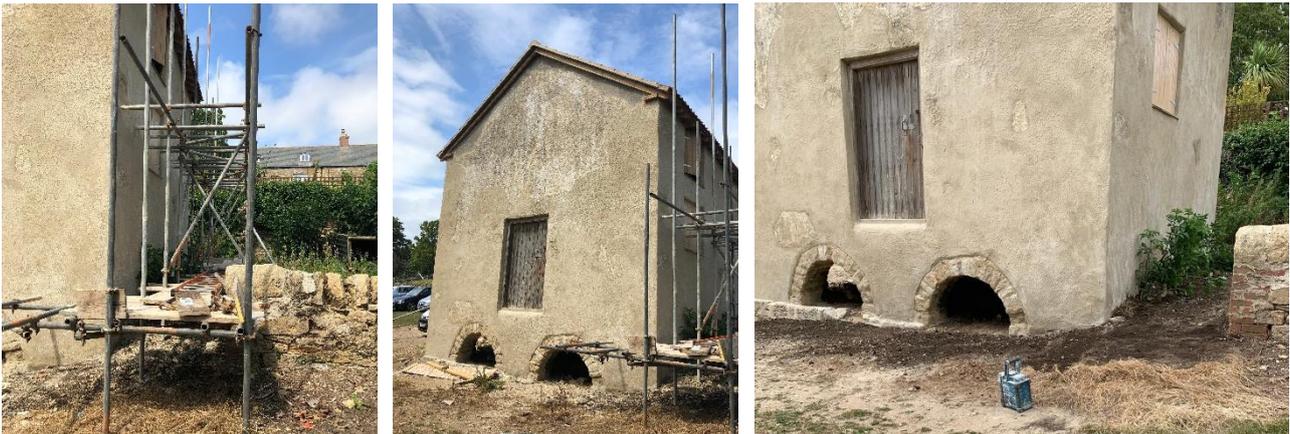
Internally, Ellis and Co replaced floor joists, applied stainless steel fitch ends and relaid the original timber floor with sections pieced in to repair original timbers which were treated against beetle damage. Windows and doors were repaired, timber window lintels re-newed. Ellis and Co's joiners created new shutters matching the originals. Instructions were provided by Philip Hughes Building Conservation.
