Case Study

Fonthill Abbey

Wiltshire

A Gothic Revival Abbey built in haste by William Beckford between 1796 and 1813. The original Abbey was short lived and demolished in the late 1800s. All that remains is the gatehouse, half the north wing and a seventy six foot tower of gothic perpendicular architecture. Ellis and Co were commissioned to restore the towers' stonework, remove ironwork, install steel supports, repair the windows and lay a new roof.

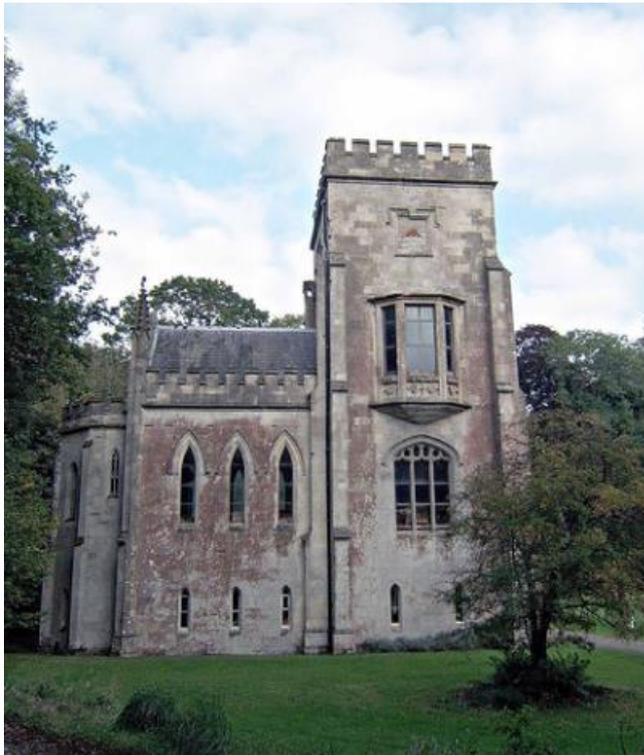
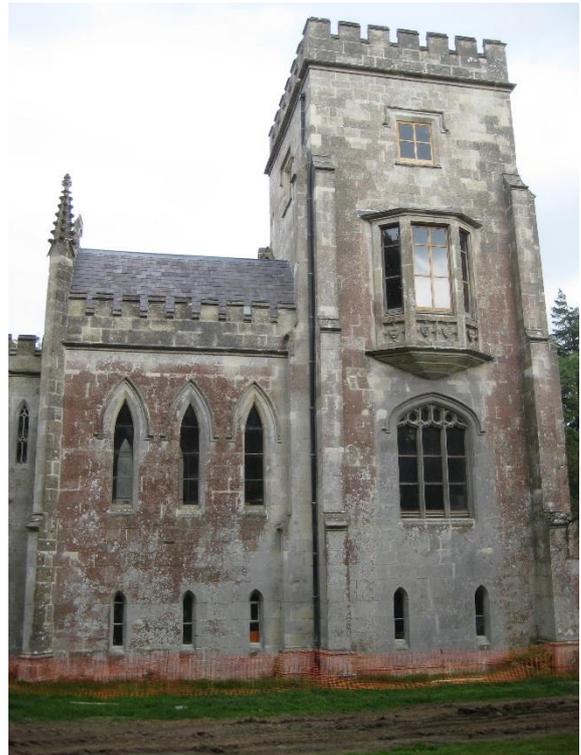
The tower of the north wing before and after works showing the new windows and stone repairs.

Stonework was cleaned, biological material removed, and stonework repaired. Corroded iron cramps were cut out and where necessary new steel cramps were inserted. Surrounding masonry which had been damaged by the ironwork was repaired. New Chilmark stone was cut and pieced in to fit neatly and tightly alongside existing stonework. Smaller gaps and joints were cleaned and filled with mortar.

The windows throughout were stripped down and repaired, including the Oriel window shown above which required additional structural support once cement and ironwork were removed. A large section of bulging ashlar was removed and replaced with stonework designed to match and fit neatly alongside surrounding stonework.
