# Case Study

## Uvedales, Corfe Castle

**Conservation restoration of Grade II listed 16<sup>th</sup> C properties on a National Trust Estate.**

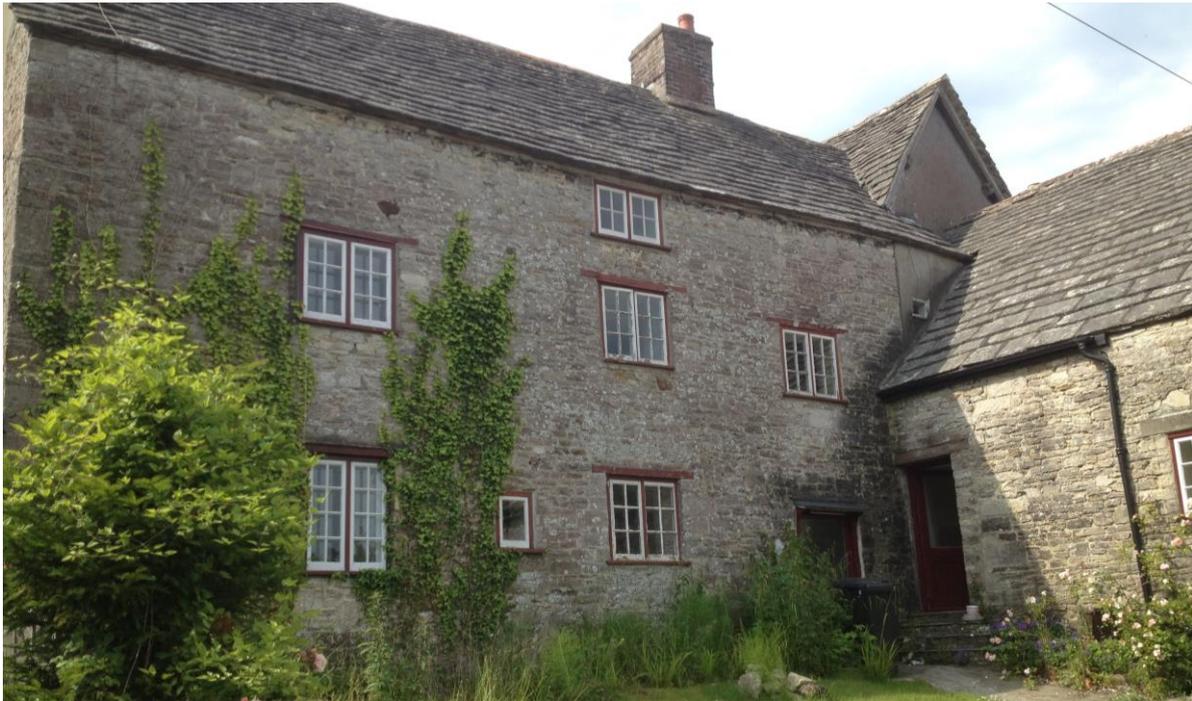
Grade II listed 16<sup>th</sup> C buildings of rubble stone walls, stone slate roofs and brick stacks. Originally a town house, converted into poorhouse in the 17<sup>th</sup> C and now part of the National Trusts Corfe Estate. In July 2016, under instruction from Philip Hughes Architects, Ellis and Co completed a nine-month programme of conservation restoration to transform the building from dereliction into four units of space suitable for accommodation.

Slate roofs were repaired and reslated with Purbeck slates from the Landers Quarry. Rainwater goods were renewed with new Ashworth iron downpipes. Exterior masonry walls and mullion windows were repaired and repointed. A new dormer window fitted. Windows and doors were repaired in situ where possible, others requiring more extensive restoration were removed and taken to the Ellis and Co workshops for joinery repairs. Additional secondary glazing was fitted to make the building insulated and sound proof. A damp proof membrane was laid. Cintec anchors were installed.

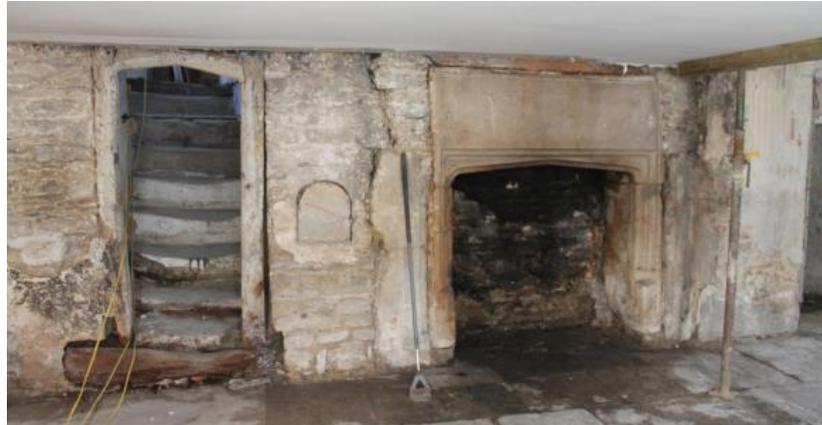
Historic timber floors were evaluated, areas of rot removed and repaired with salvaged replacement timbers. Flagstone flooring was also relaid over a dampproof membrane. Staircases were refurbished, one unsafe staircase was reinstalled in entirety.

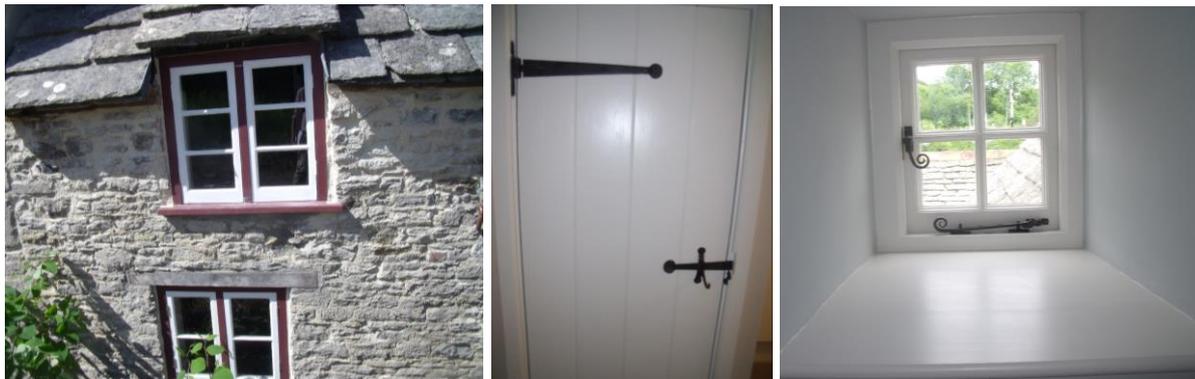
The restored doors, windows and lime rendered walls were decorated with a schedule agreed with the National Trust.

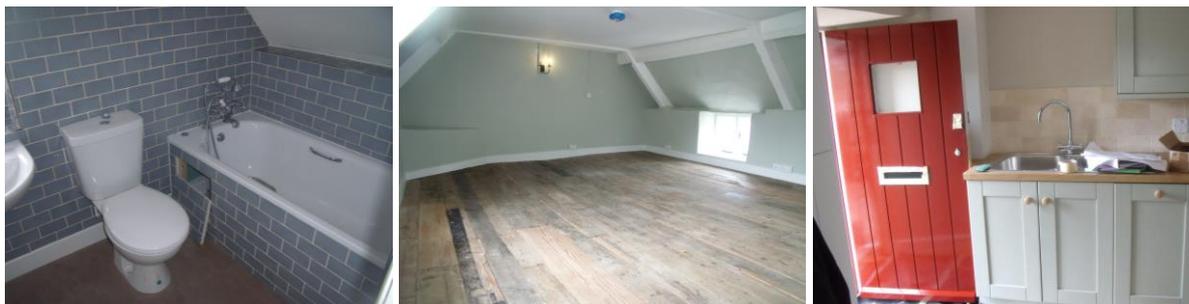
New services included complete rewiring, gas supplies, heating and hot water systems. Bathrooms were tiled and fitted, and kitchens with bespoke oak units were installed. Some walls were relocated to provide a new internal layout and a derelict attic space was converted into accommodation. Externally outbuildings were demolished, below ground drainage added and gardens landscaped, including a new driveway and parking areas.
